Fatwood friends (Fetvedens vänner)

The main objective is spreading the knowledge about artificial aging of trees.

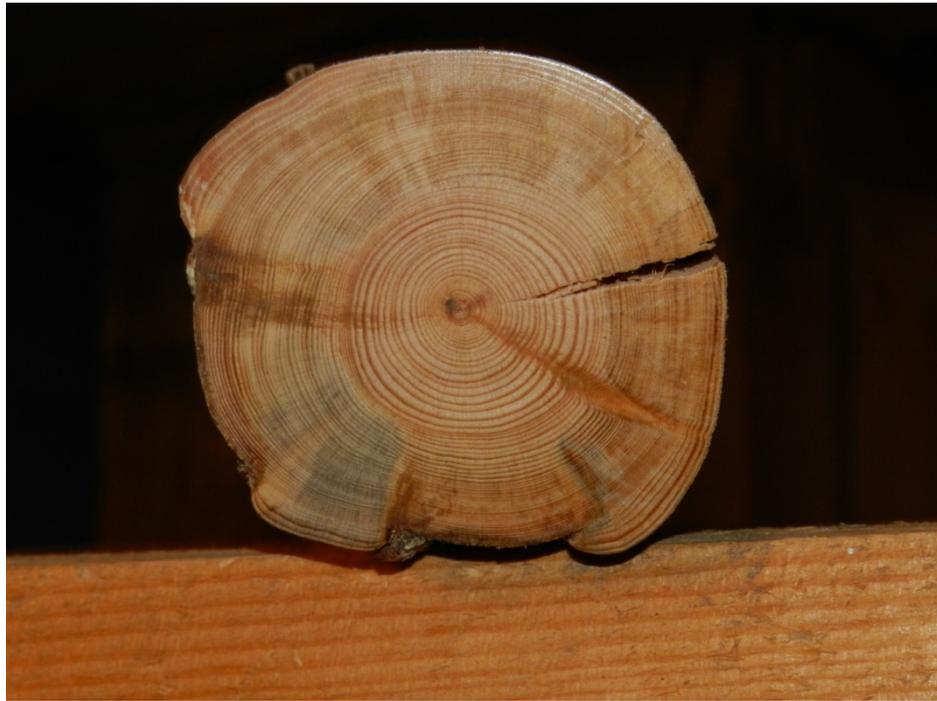
The beginning of Fatwood Friends, If elks can do it so can !!!

Here we see a 4" thick log that has been injured and felled by an elk.

We can clearly see that in the debarked areas fatwood has been produced and also signs of an increasing heartwood is visible.

In the uninjured areas, where the bark was still intact, discolored wood (pioneer fungi) has developed in the sapwood. This is proof that the method of systematically debarking a tree actually works.

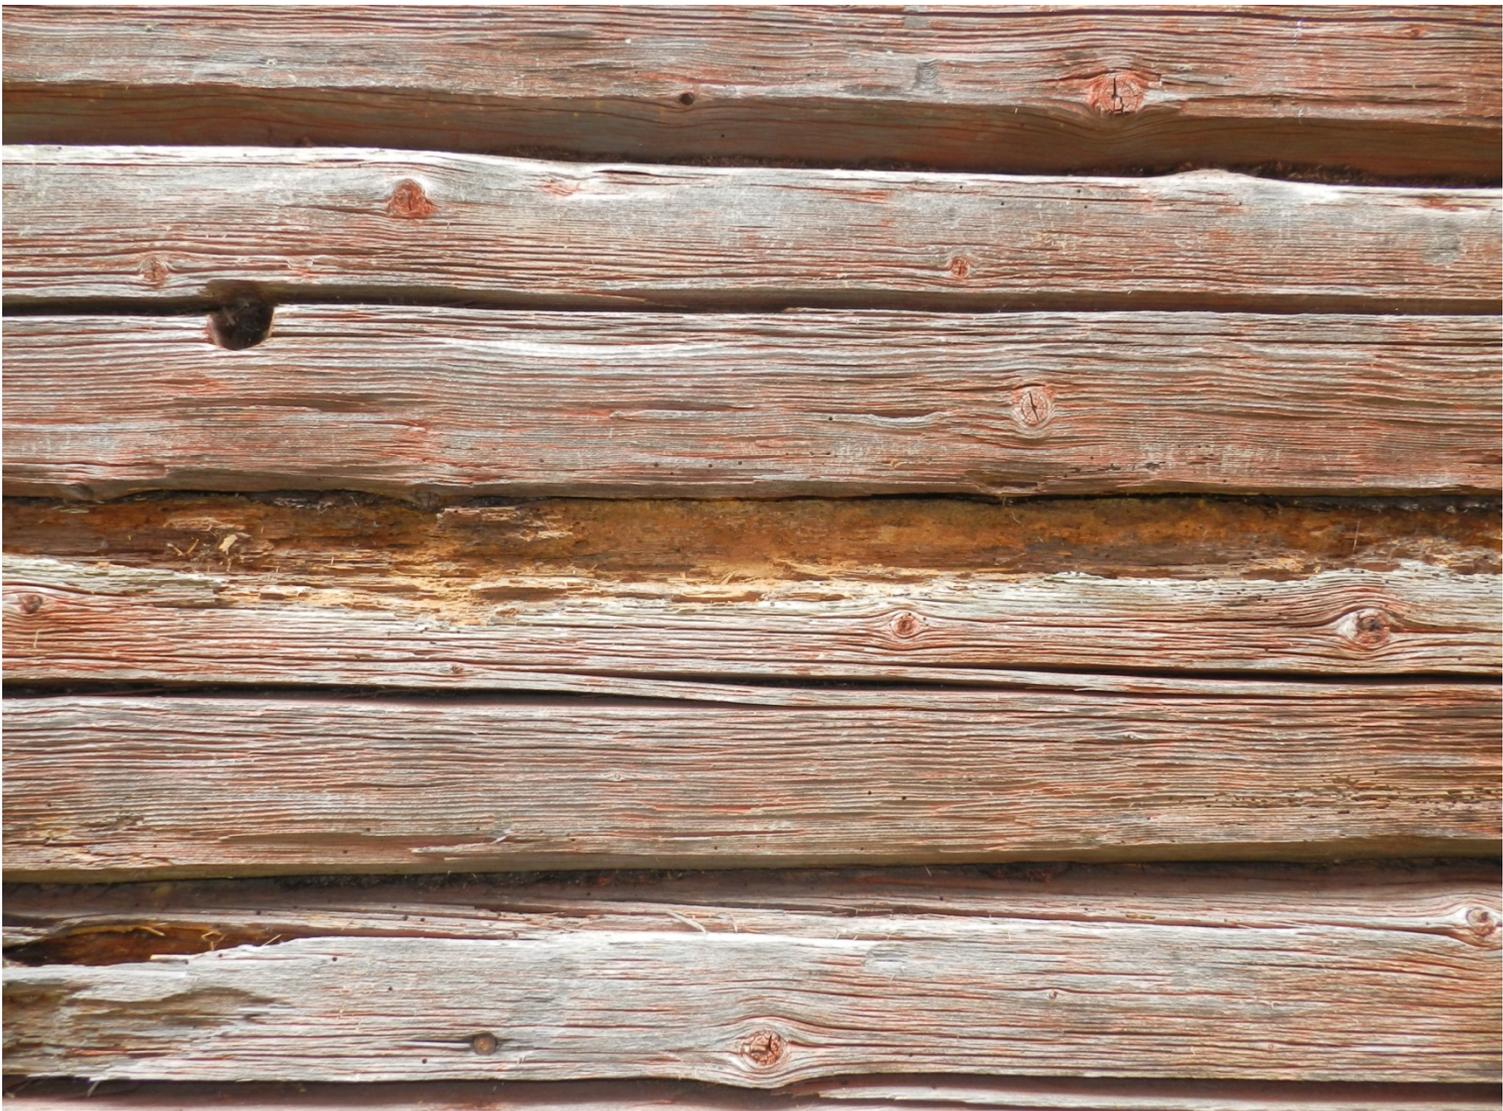
Classic rot injuries on logbuildings

But through systematically injuring of the trees we impregnate the sapwood with natural resins with a high concentration of Pinosylvin, which is the most rot resistant content that can be produced.

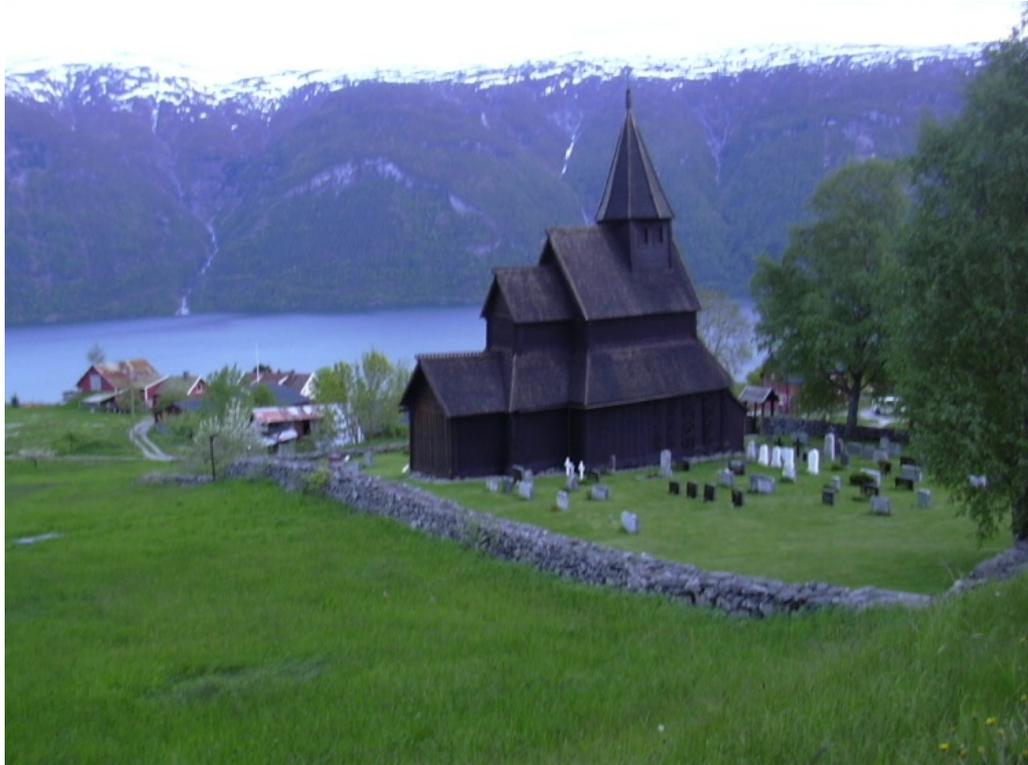
Urnäs stavechurch, in Norway from the 13th century

In this church it is said that the staves are produced from treetopped trees where only a small part of the crown was kept on. The trees then stood for another 15-20 years before they were felled, followed by the production of staves that ultimately were incorporated into the church.

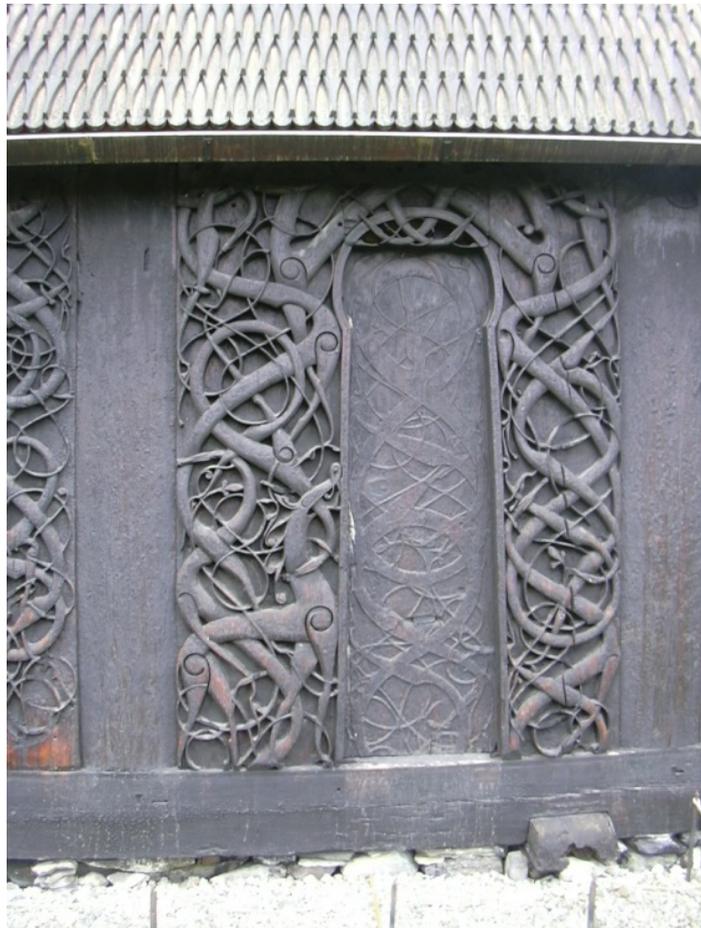
Urnäs stavechurch, in Norway from the 13th century

Here we see the oldest portdoor which is from the year 1050. Here they have chosen to use materials with a high concentration of resins which makes it very hard. This has made it possible to handcraft these fantastic and thin ornaments.

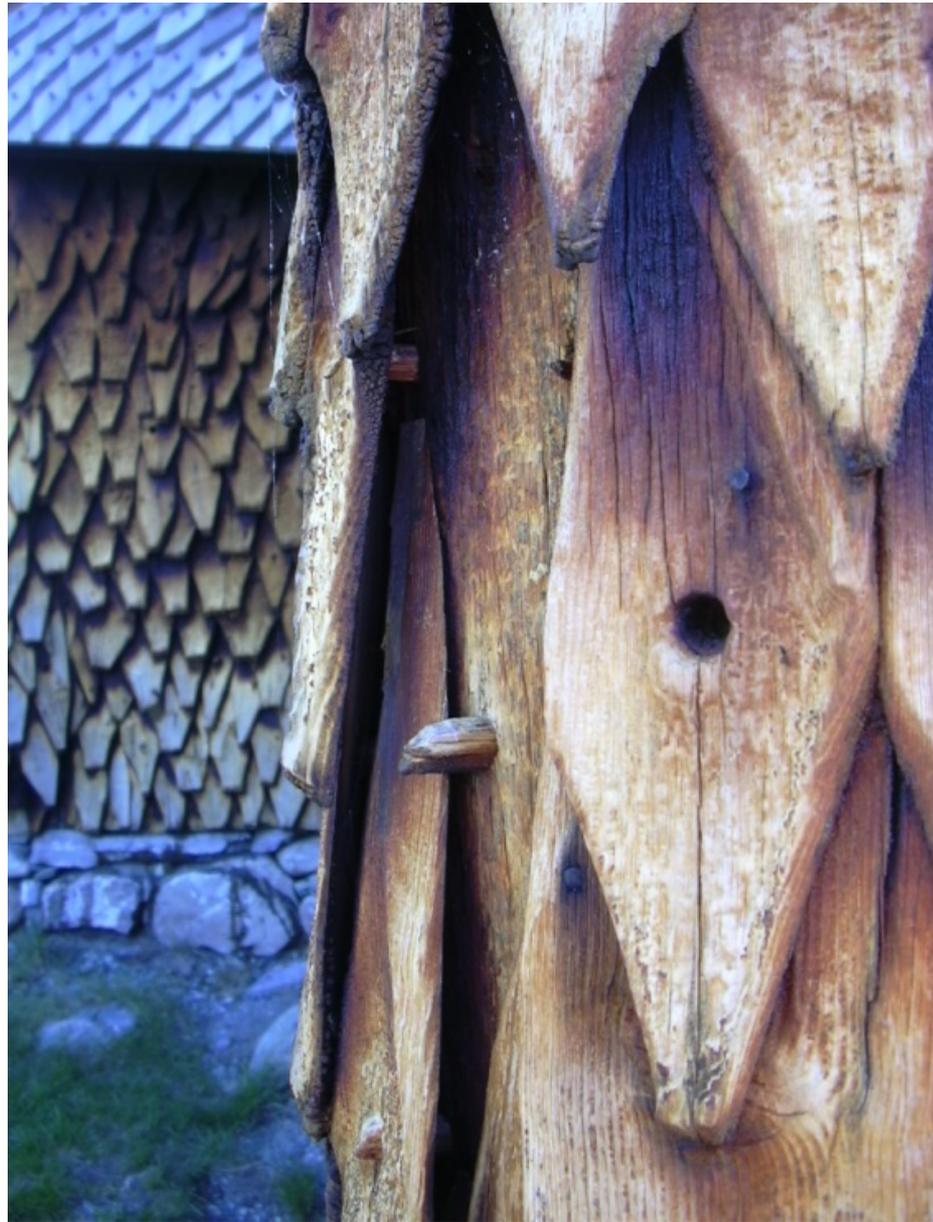
800 years old shingle on a stavechurch in Norway

**If you use material with a high
quality, standing annual rings
and a high concentratin of resin
(fatwood) then it will last for
many hundred years.**

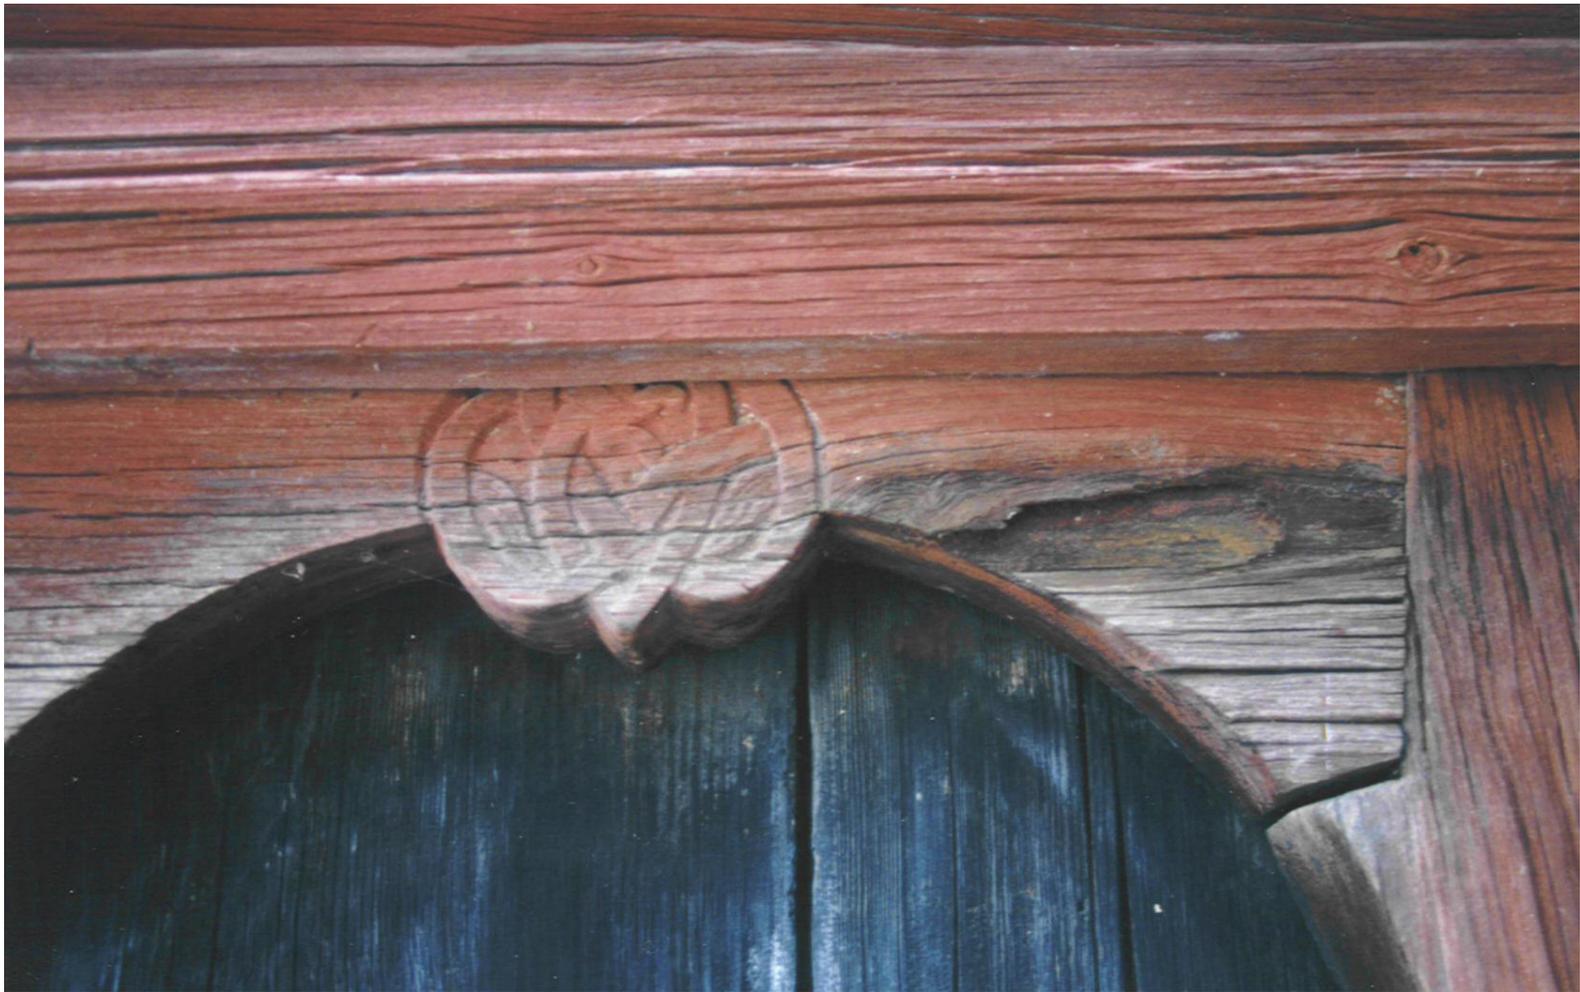
Yghärbret dated to year 1315 -16, Hälsingland , Sweden

By using burned wood in the buildings you increase the durability and get a formstable material.

Today, wood burned like this, would sadly be classified as useless.

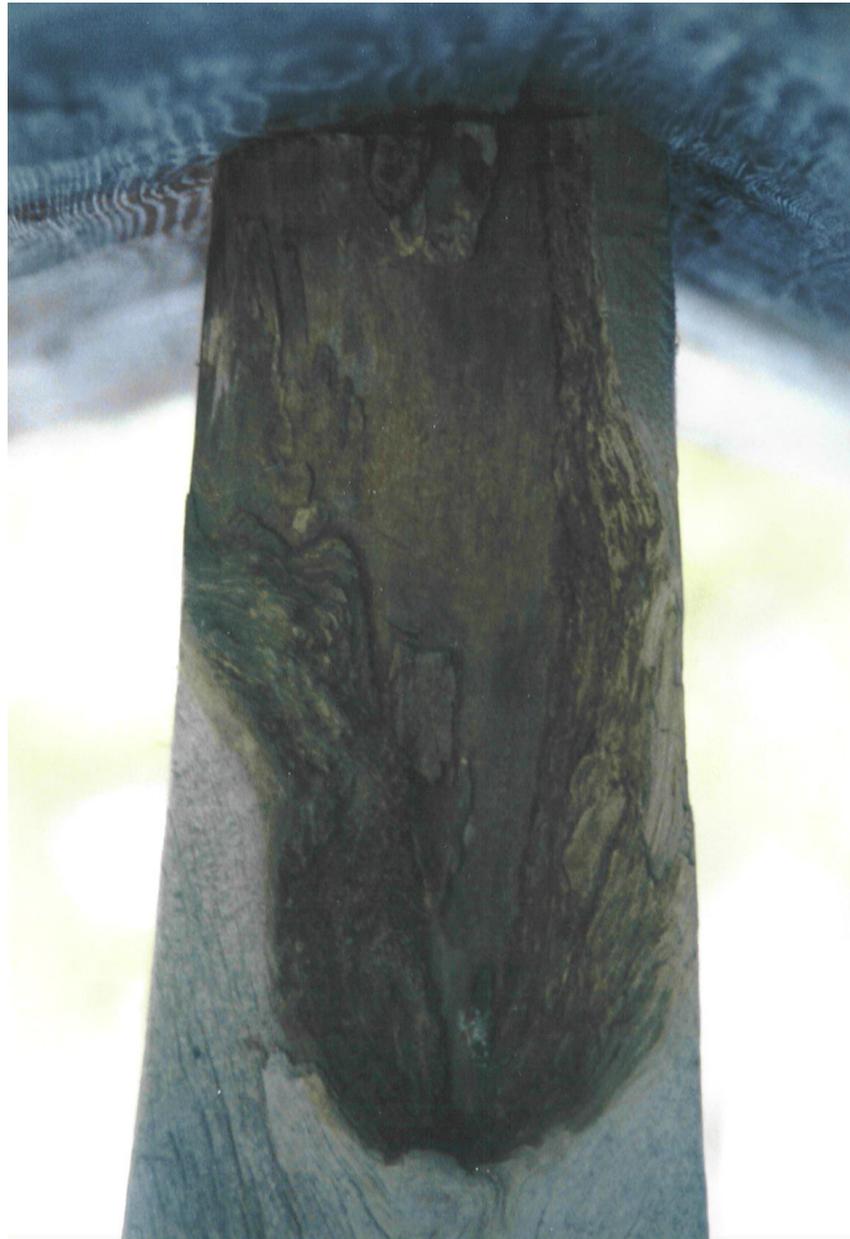
Cottagepillars with rodentshields Hälsingland , Sweden

Another example where burned wood has been chosen because they wanted rotresistant cottagepillars.

These cottagepillars stand on the sill-log (bottom log) and on top of these are rodentshields to prevent rodents from entering the cottage where the food is stored.

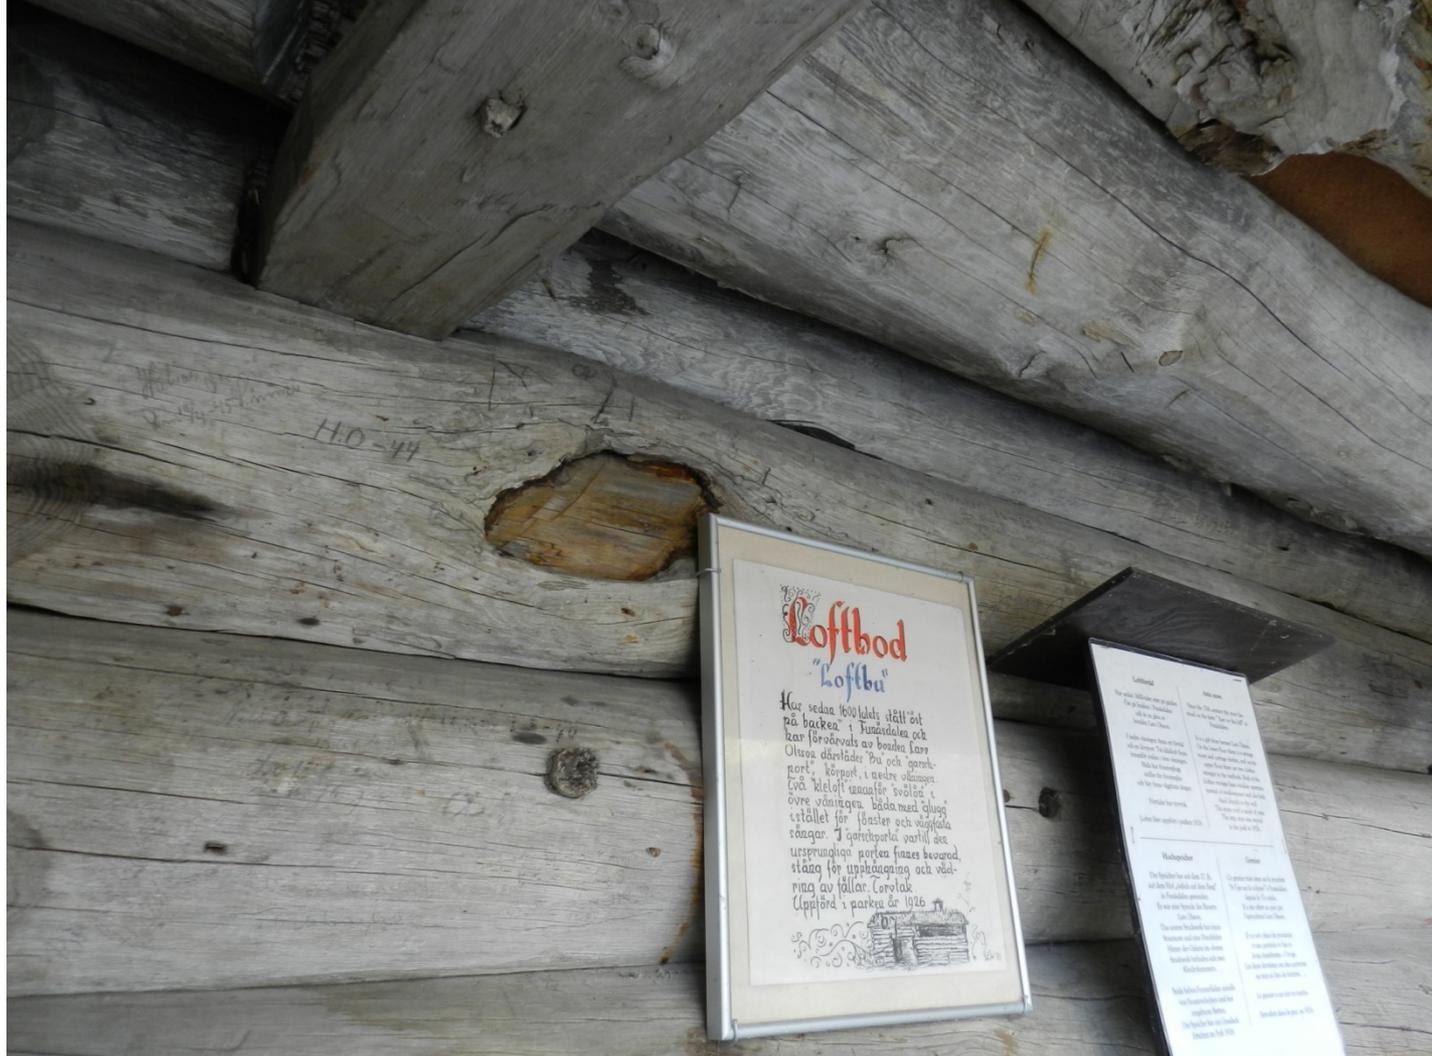
Cabion from the 17th century, Härjedalen, Sweden

Here someone has deliberately spotbarked the, to naturally produce the resins in the wood, which is to increase the rot resistance. It happened many years before the tree was felled

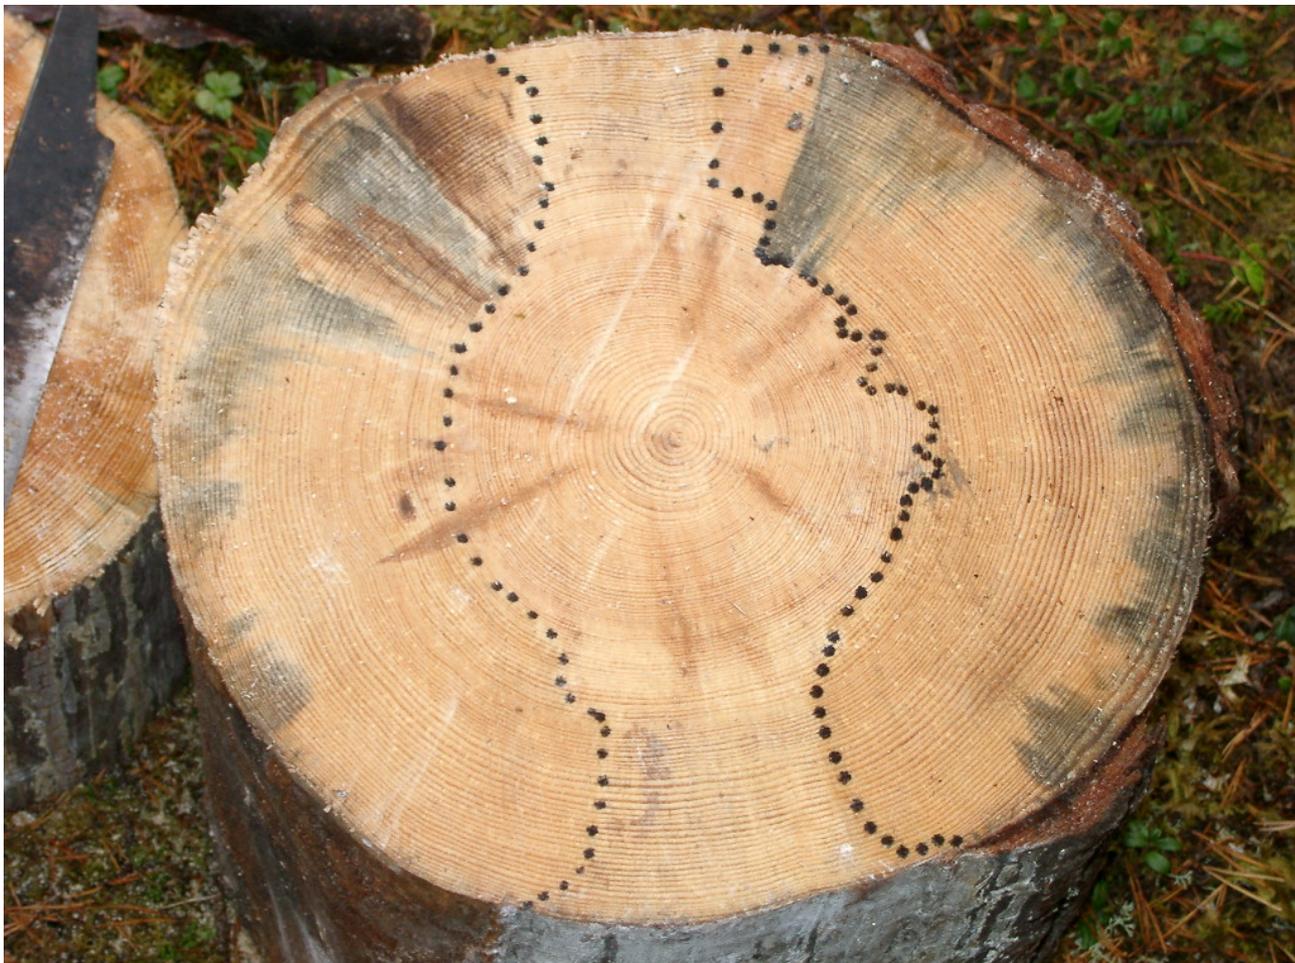
Ocular pioneer fungi test

This tree fell over by the wind 1,5 years after it was stripebarked. It was then left on the ground in the forest to see how the stripebarked sides protects the tree from rot and pioneer fungi. The positive effect of the stripebarking is pretty obvious

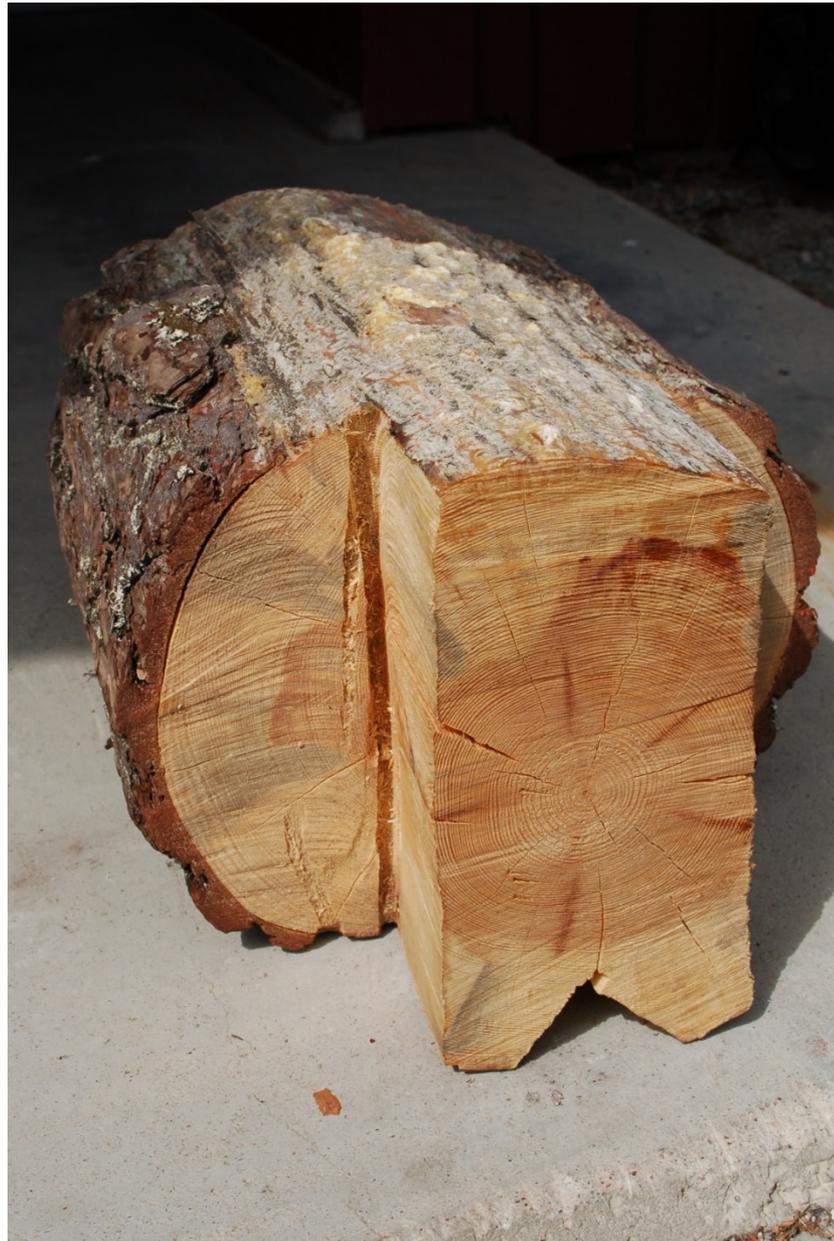
The "Barking" must be done in the "savningstiden"

**"Savningstiden" (end of the
springtime, mostly june) varies
both geographically and in which
height above the sealevel the
tree is growing.**

**When the trees start developing
3 inch shoots, it is the right time
to start the barking process.**

**It's very important to remove all
the innerbark (cambium),
otherwise no resins/fatwood will
be produced.**

**Th tree in the picture is barked
specifically to produce church-
shingles in a traditional way with
standing annual rings, by axe.**

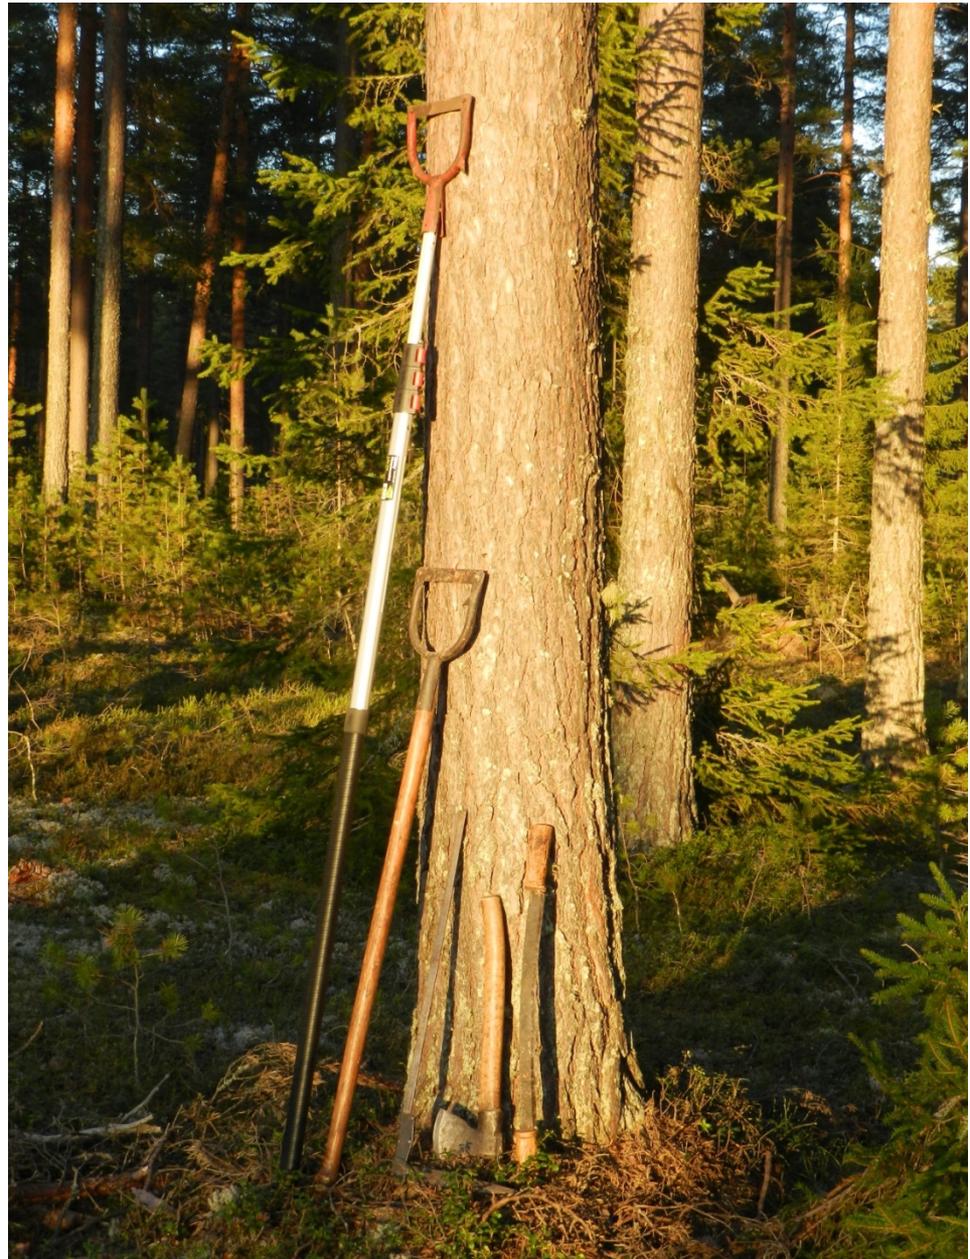
Barking the first year

Here it is barked on both sides with 7-8cm (3 inches) wide stripes that are approximately 8 meters high

A similar stripe is barked on the exact opposite side.

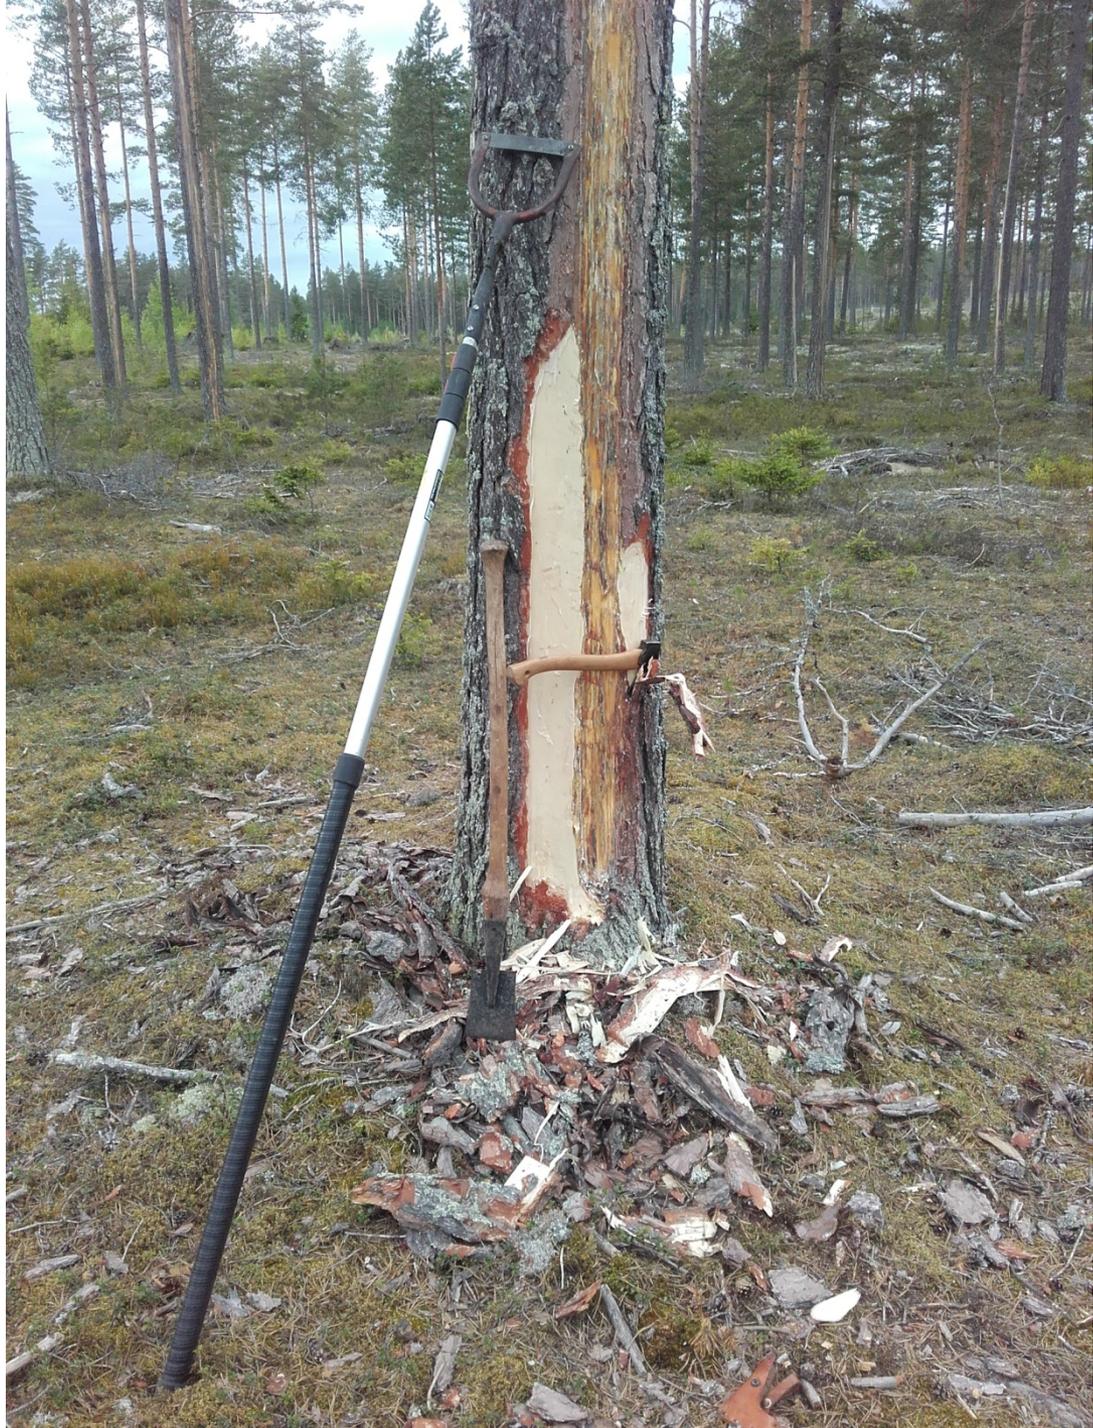
Widening of the previous years stripebarking

It is very important to remove all the innerbark (cambrium) so that the tree realizes that it's been injured and starts producing resins to "close the wounds" and protect the tree from the outer elements.

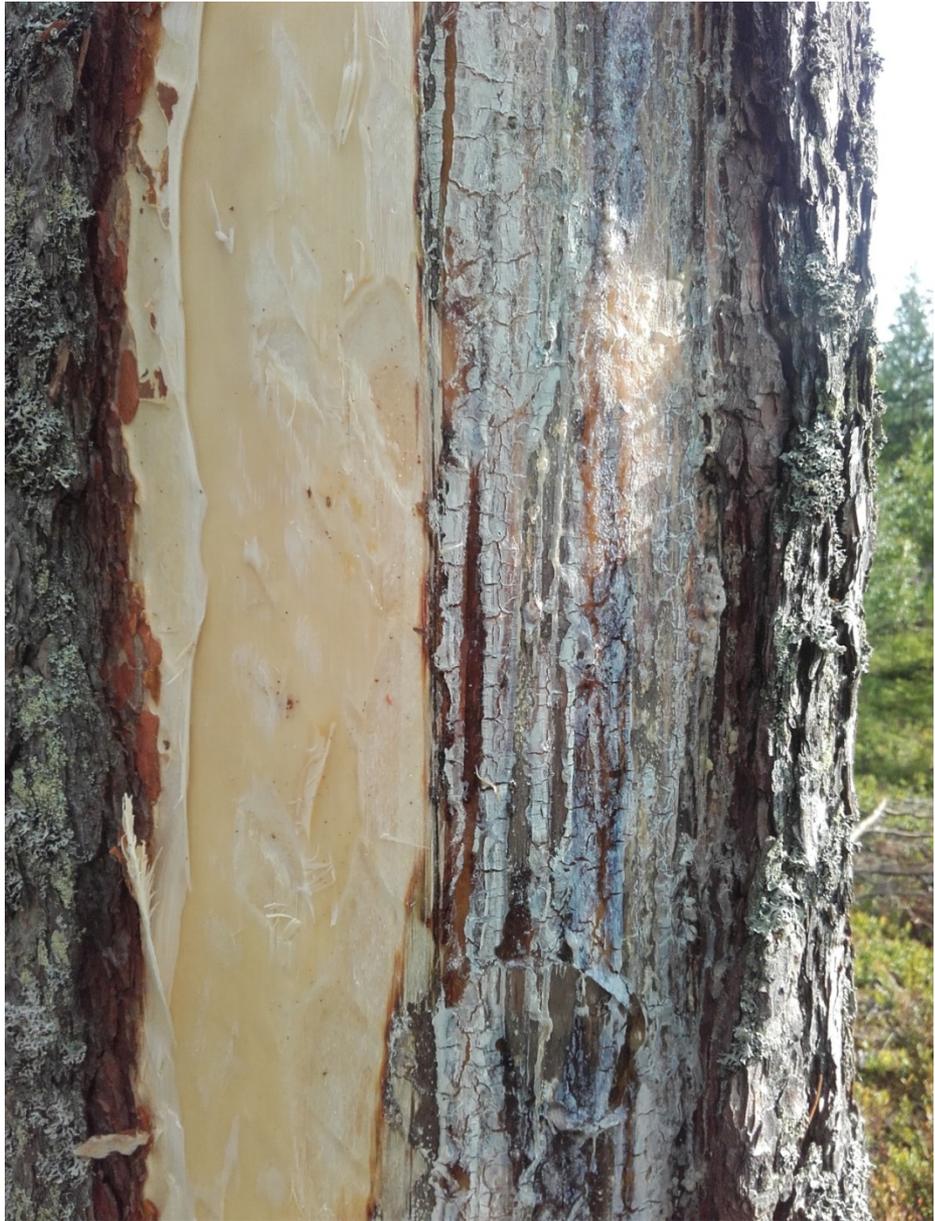
The 2nd year of barking

This is what it looks like, on one side of the tree, after the second year of barking

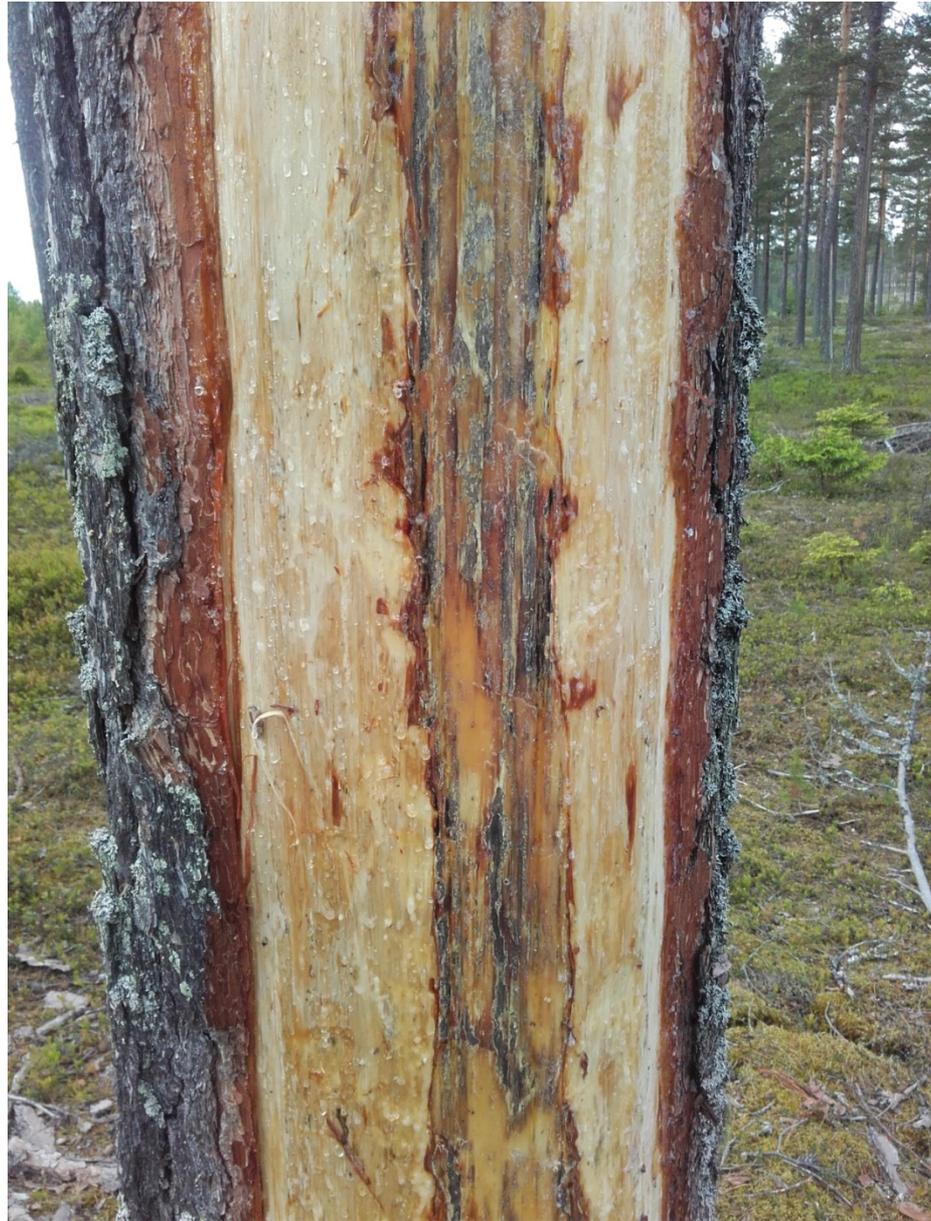
Barkningschema vid framställning av fetved till kvarterssågning. Ränderna breddas årsvis på vardera sidan om den tidigare barkningen.

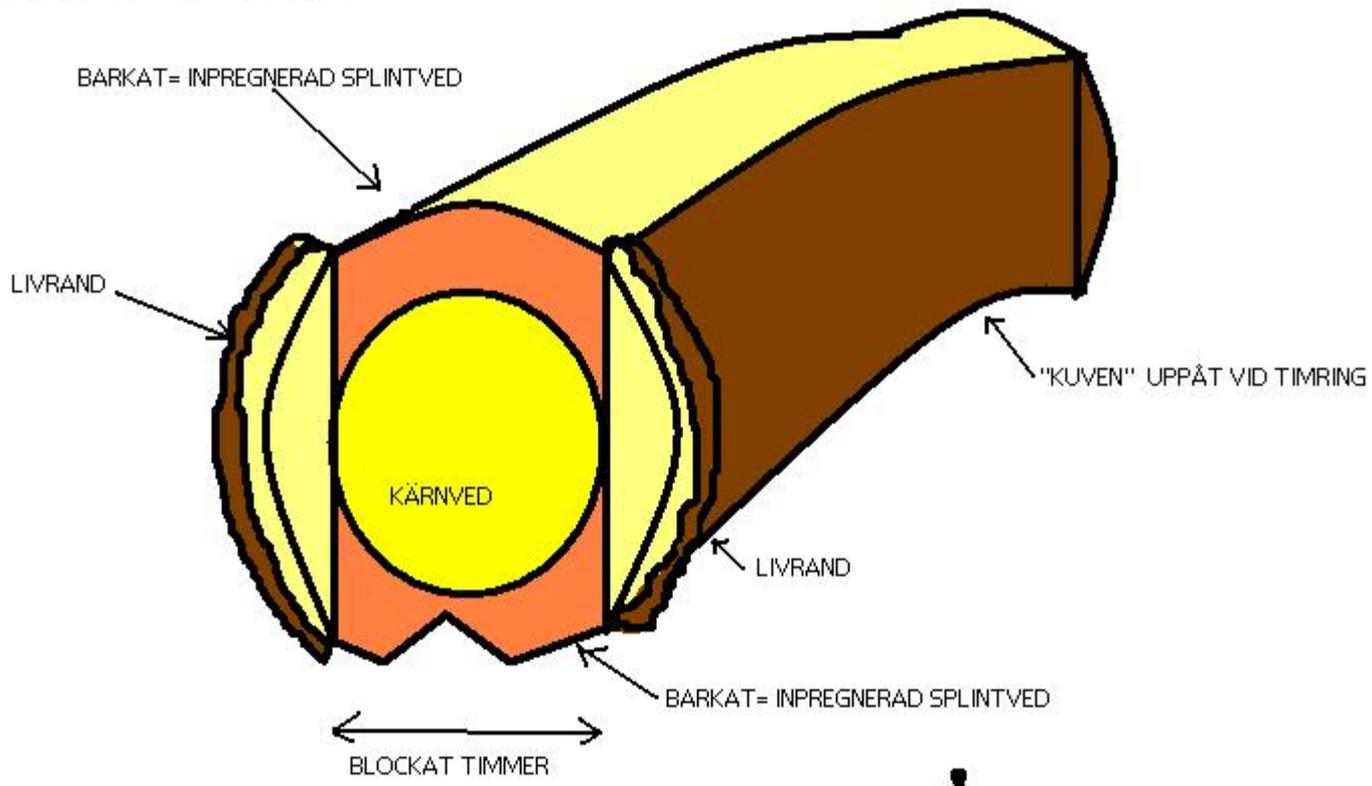
Suggestiv barkning av tallar på rot.
Principskiss

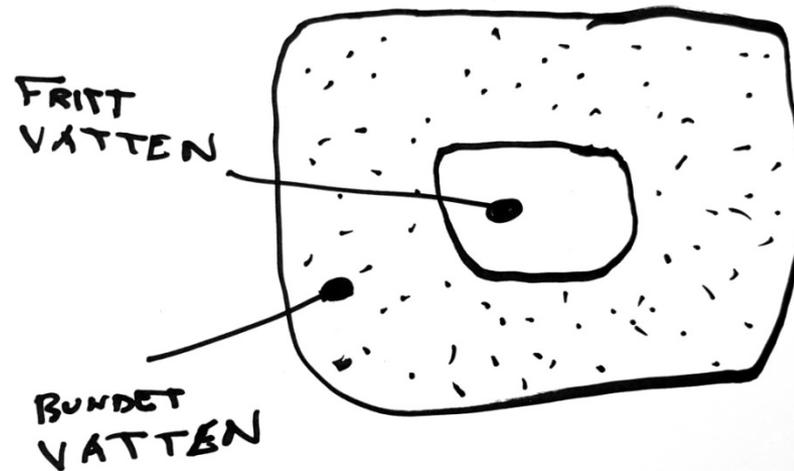
VEDCELL

The woodcell

The cells walls consist of cellulose which sucks up water and binds it very slowly.

The water is contained in the center of the cell and fills up and drains rapidly.

The material deforms as a result of these changes.

When you bark an unfelled and live tree these cells are impregnated with resins and other rotresistant substances which results in a formstable and hydrofobic material with a very high resistance against rot.

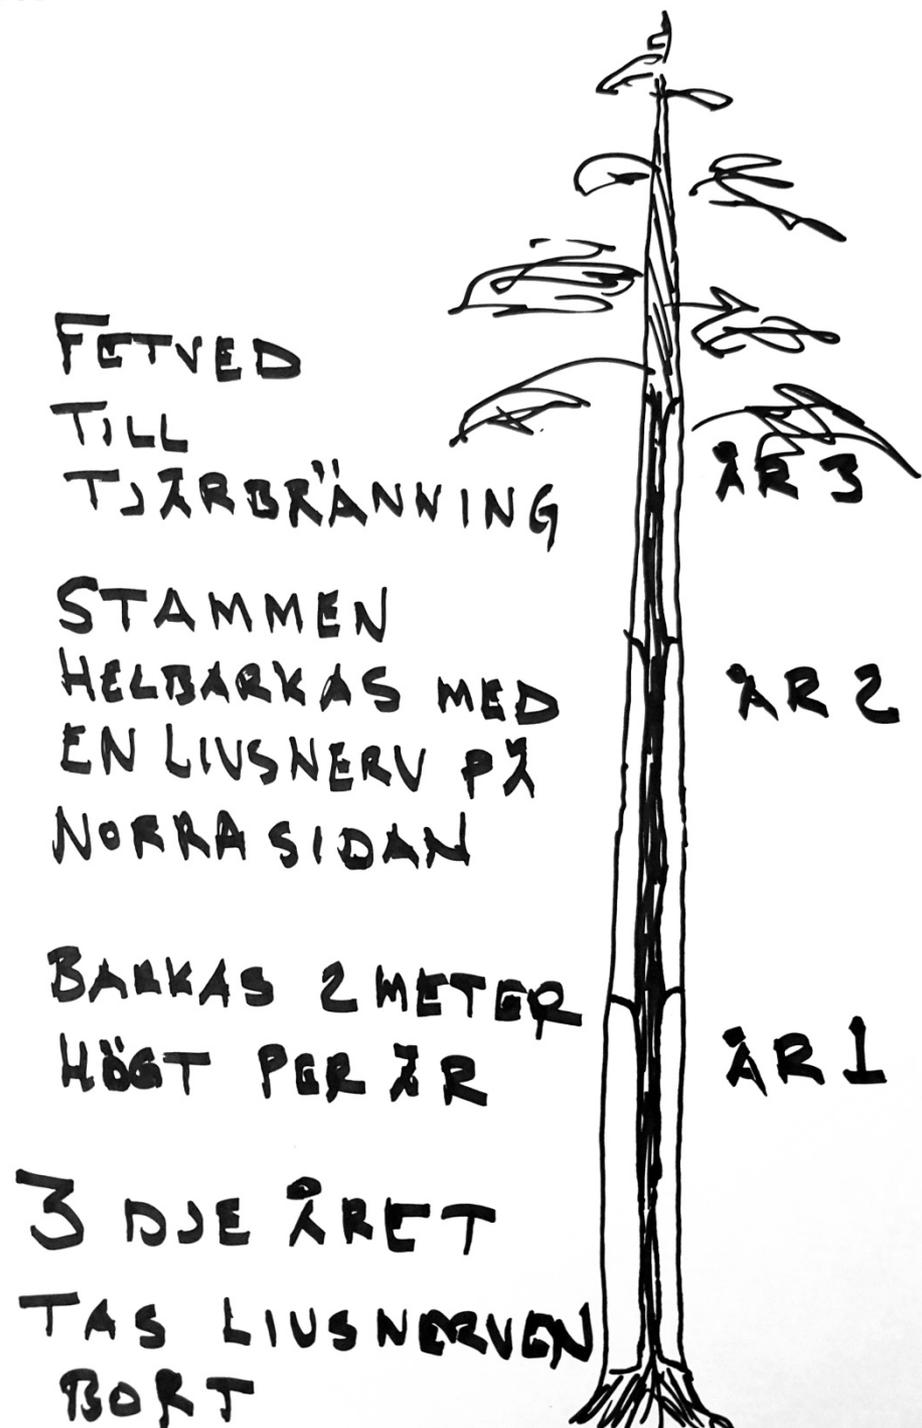
Fatwood for tar-burning

- The tree is completely barked except for one lifeline on the north side
- This is done 2 meters high each year
- The 3rd year the lifeline is removed

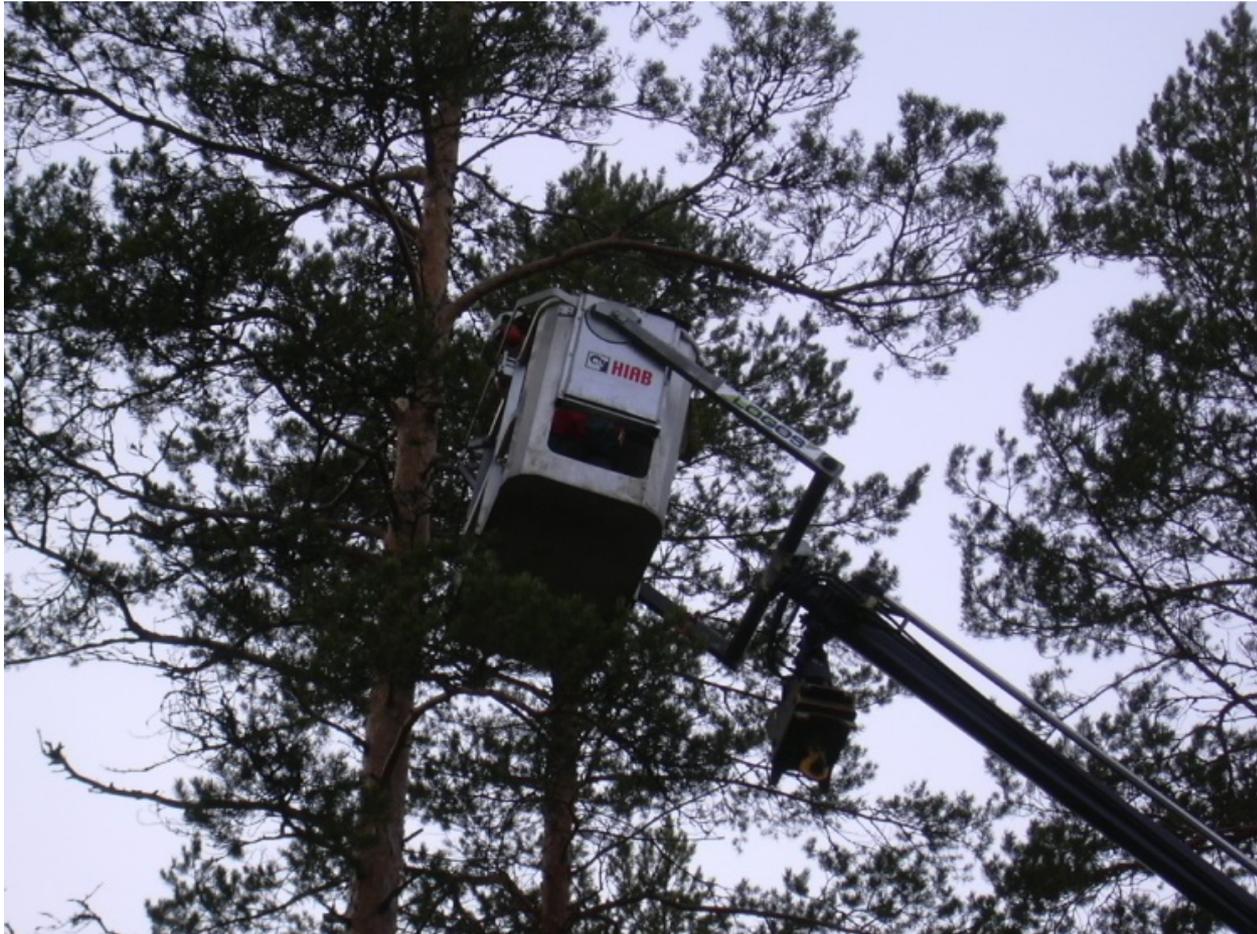
Treetopping 2005

In 2005, we treetopped 14 trees with a small part of green (the crown), approximately 30%, still left on top. After 8 years we took root tests and became disappointed in the results as it showed that the rotresistant substances did not develop as we had hoped for.

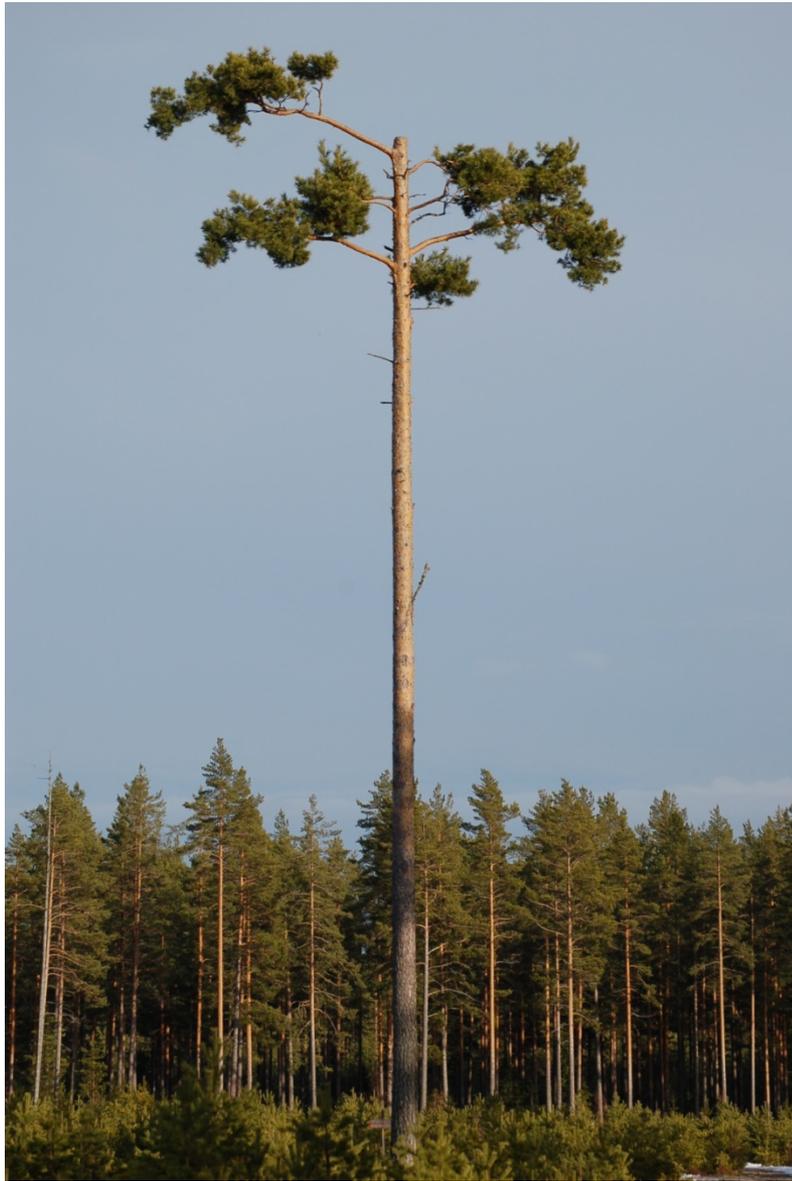
One of the topped trees

When treetopping it's important to top the tree right above a branch. This is to prevent rot in the cutted surface since the resin canals operate horizontally.
