Fatwood friends (Fetvedens vänner)

The main objective is spreading the knowledge about artificial aging of trees.

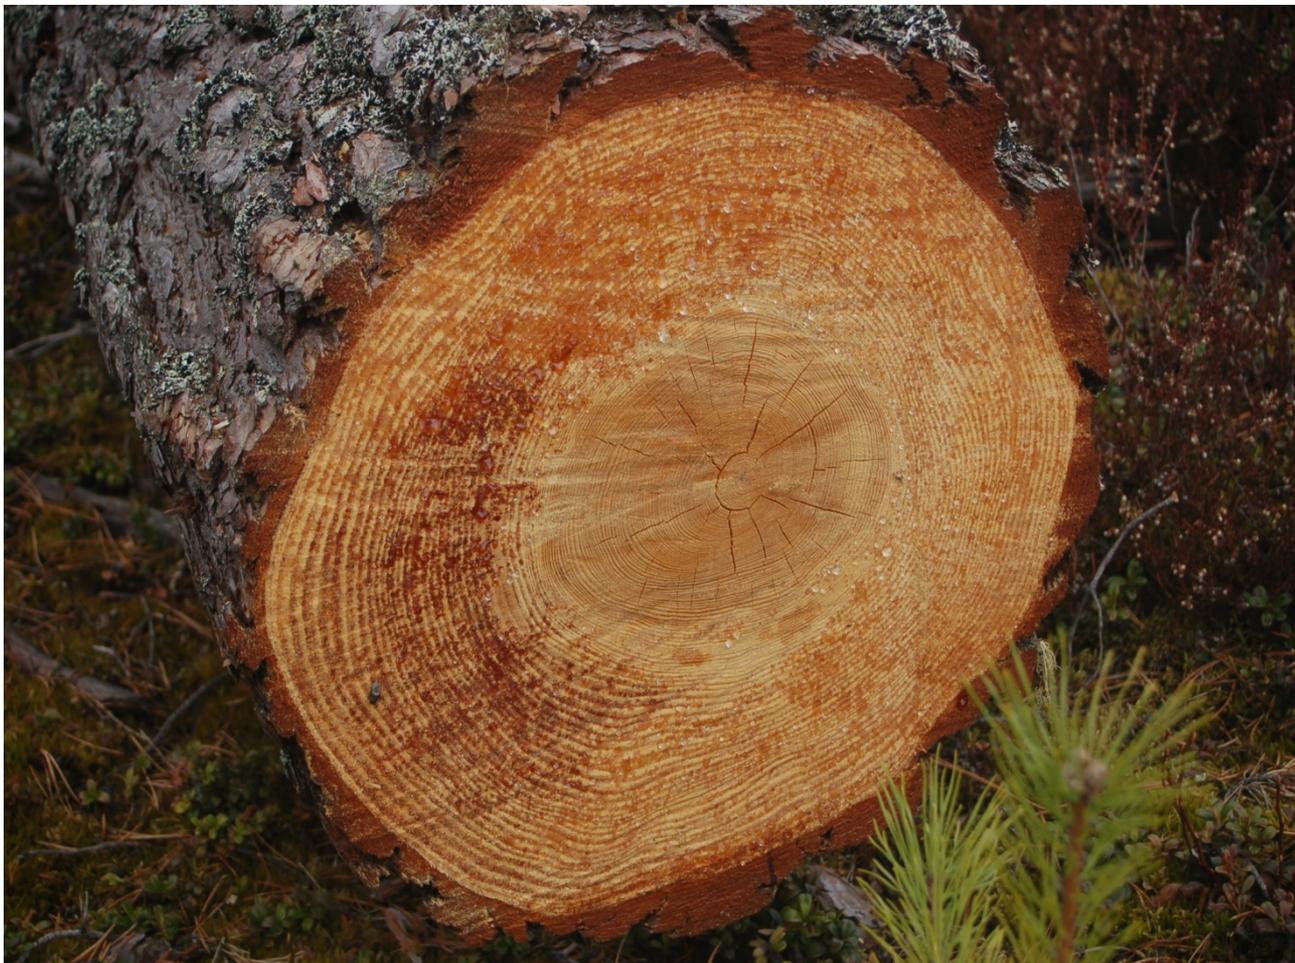
Treetopped tree that was felled after 2 years

By treetopping the annual rings grow considerable less.

Even after 8 years the tests showed that the rotresistant substances produced were a lot less than we had expected.

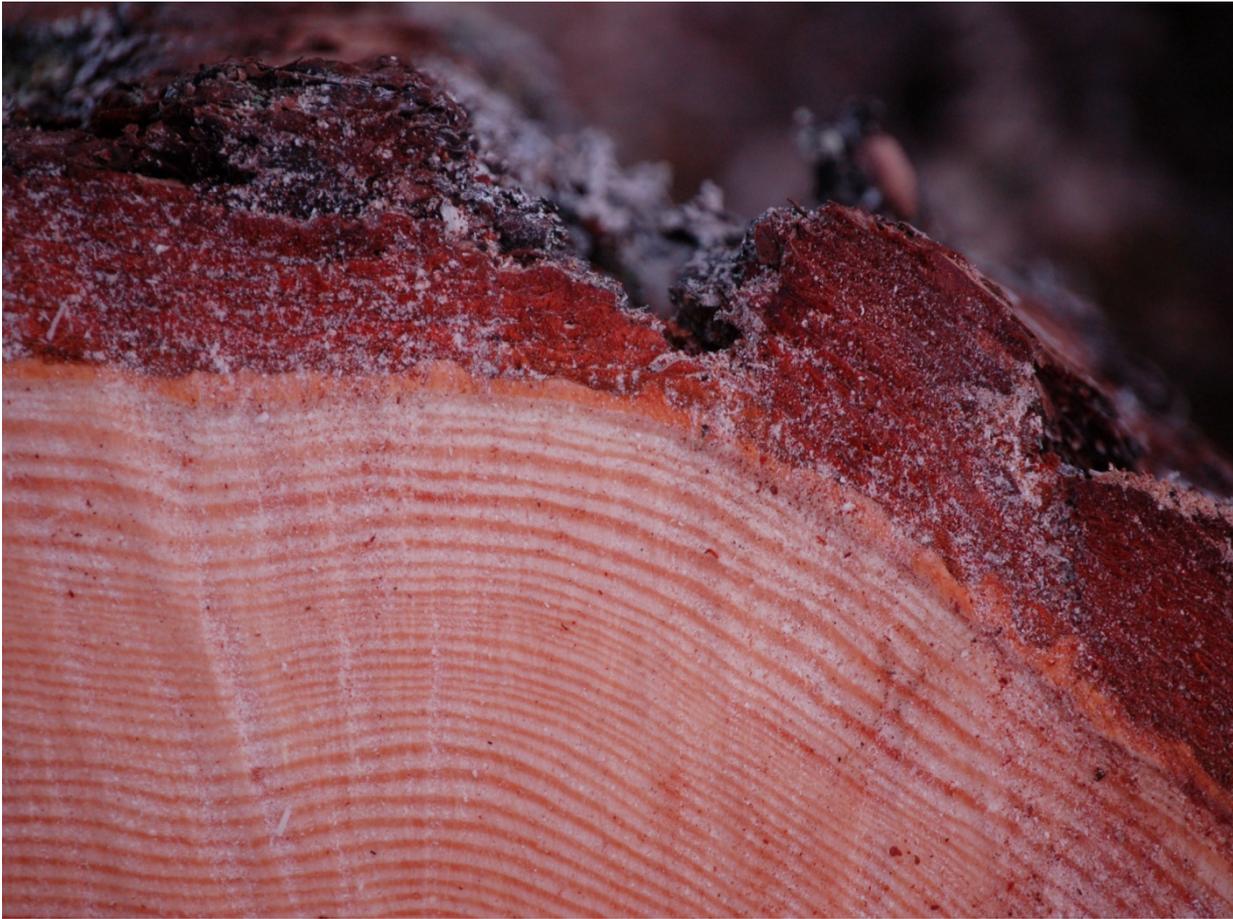
Treetopped with reduced diameter growth

The 2nd and 3rd annual ring is significantly reduced after the treetopping. But the most outer ring has increased its thickness. Most probably because of increased greens in the crown.

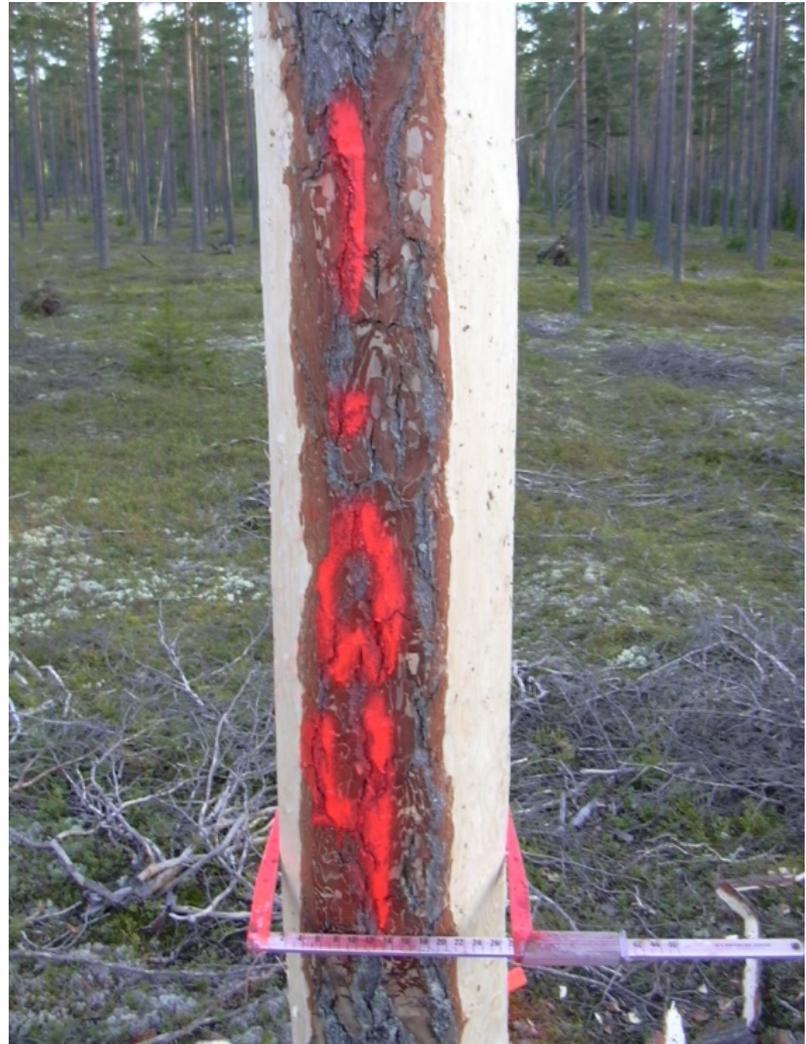
Dripping resins

Our earliest stripbarkings were done with 15-20 cm wide stripes and this resulted in that the resins "bleed" out of the tree and drips down. This also develops drying cracks in the wood.

We prefer to have the resins stay inside the tree.

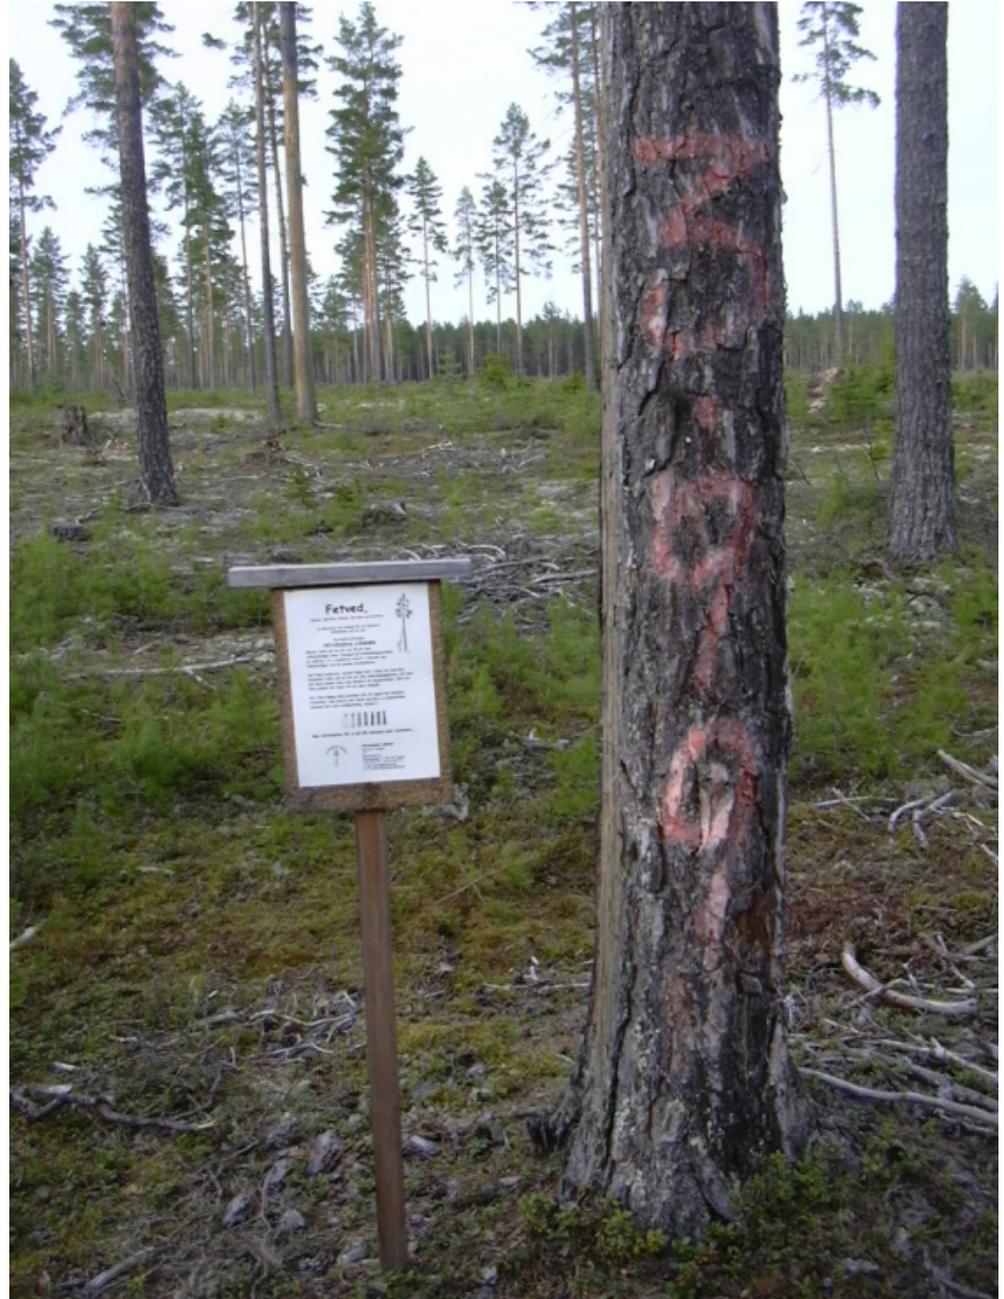
Tree nr. 2 in 2002

In 2012 we chopped off this spot with an axe to see how it had developed after 10 years. The results were very positive.

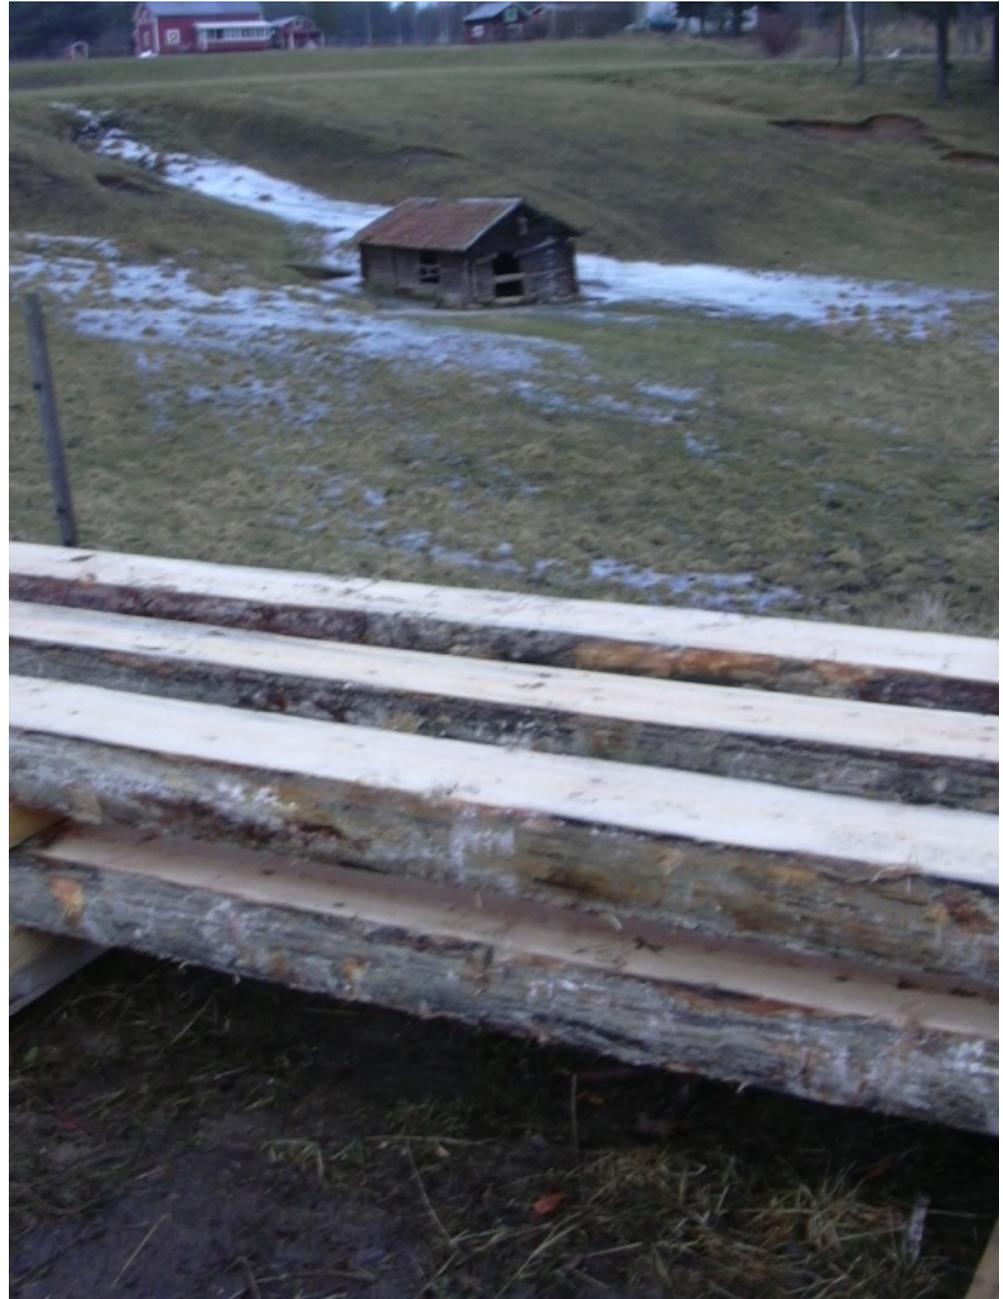
**A forge from 1801,
Rengsjö , Sweden**

**Fatwoodtimber is waiting to be
incorporated into this forgecabin.**

**The barked trees have been
standing for 5 years after the
barking started before eventually
felled.**

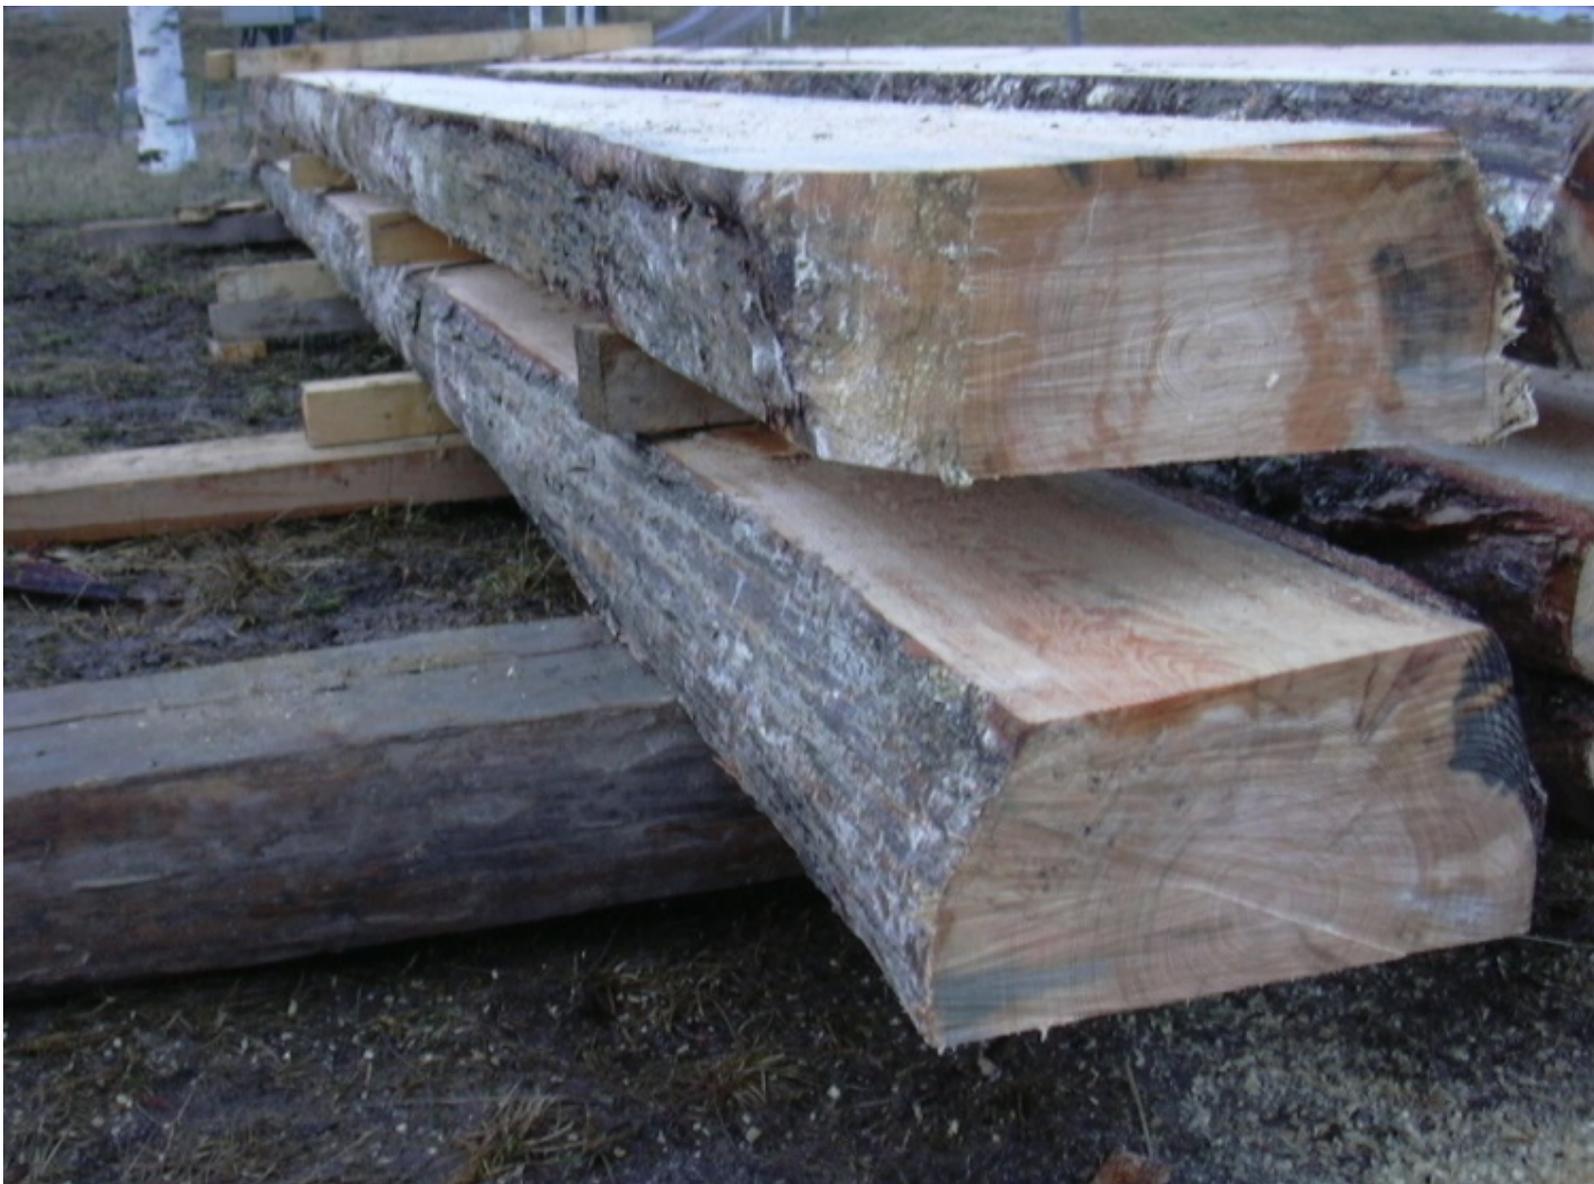
Sinds the barkingstripes were to wide on these trees the pioneer fungi has gotten the chance to develop in some parts.

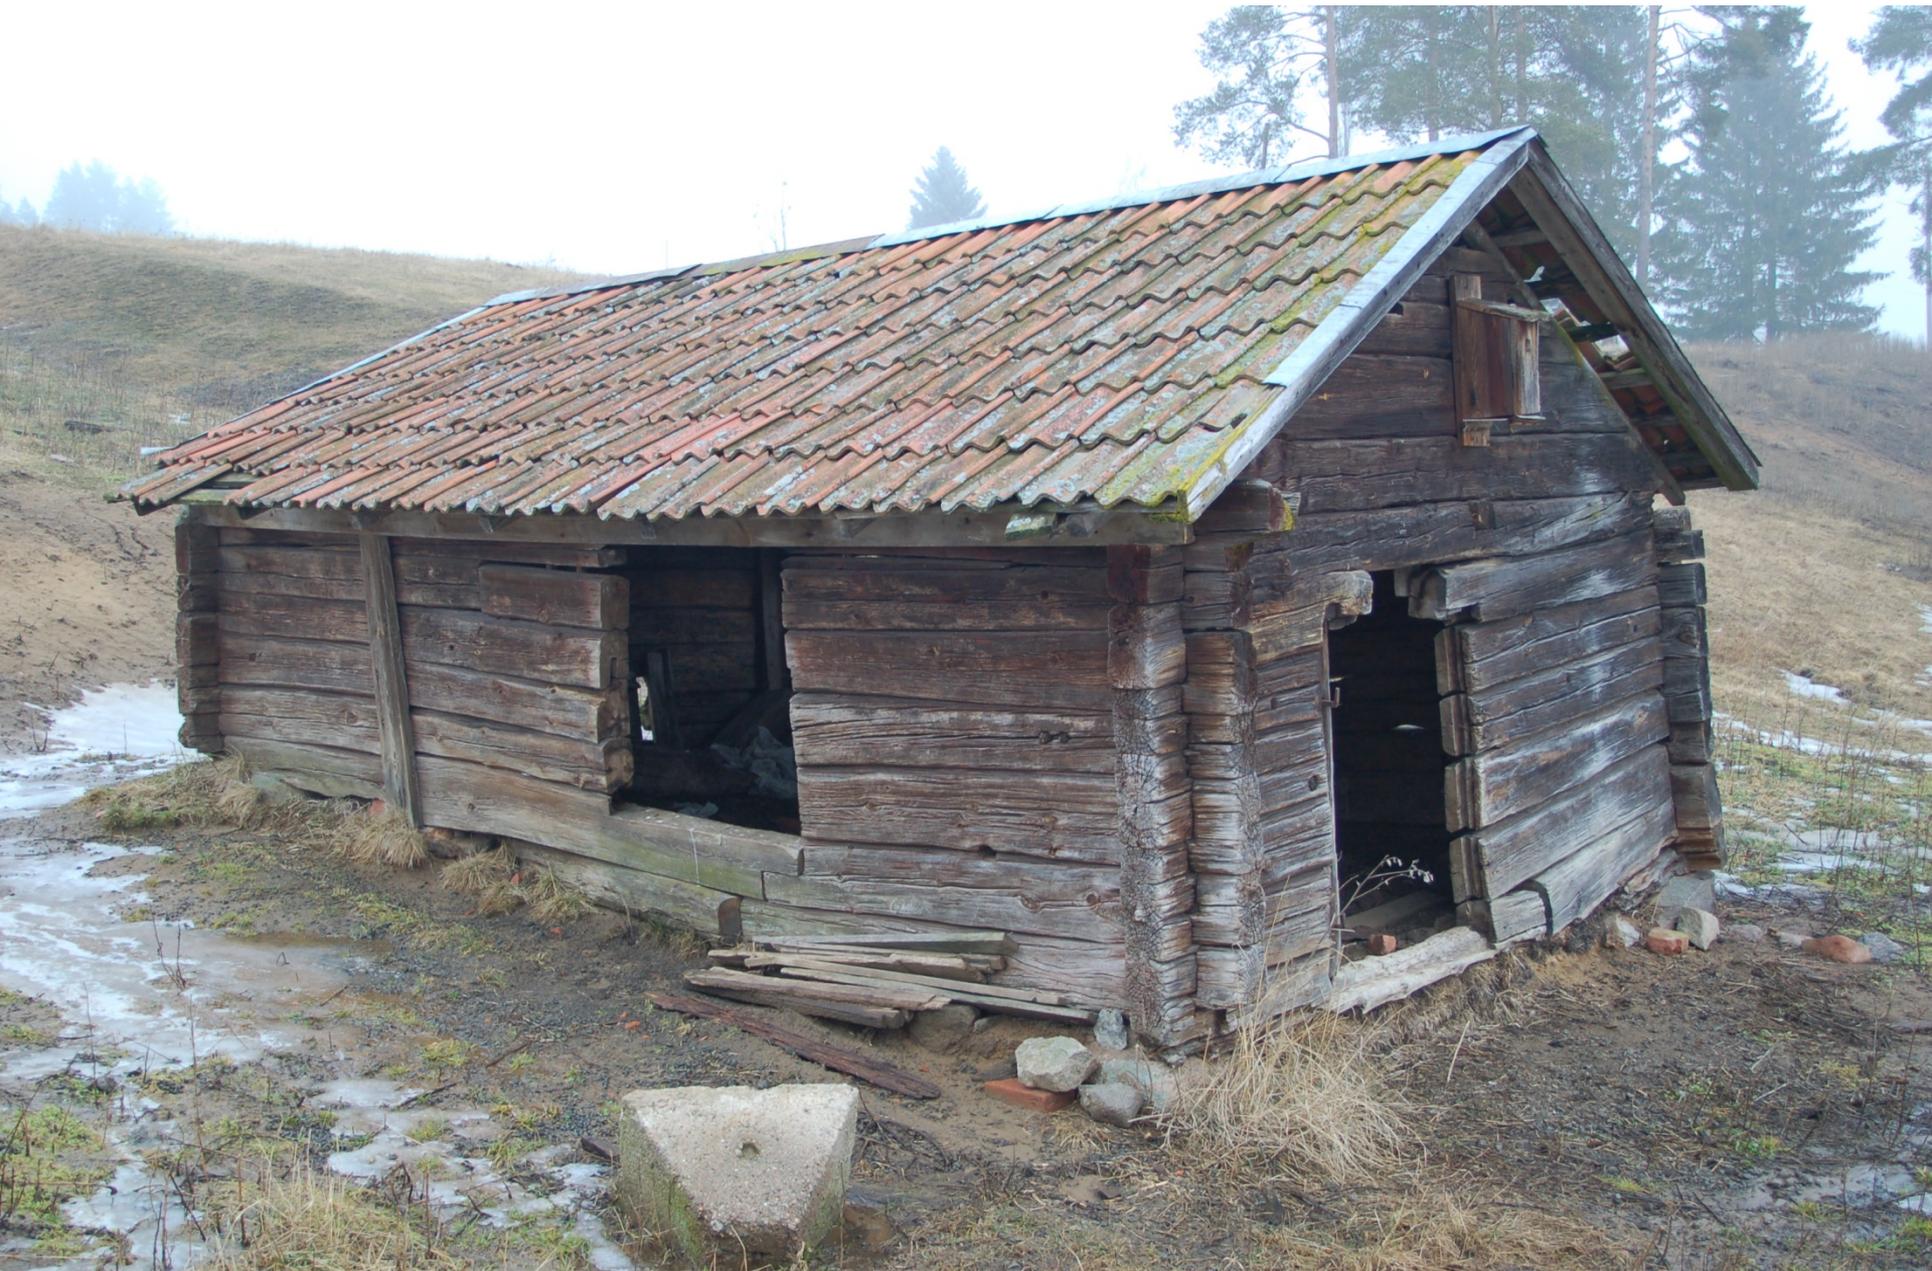
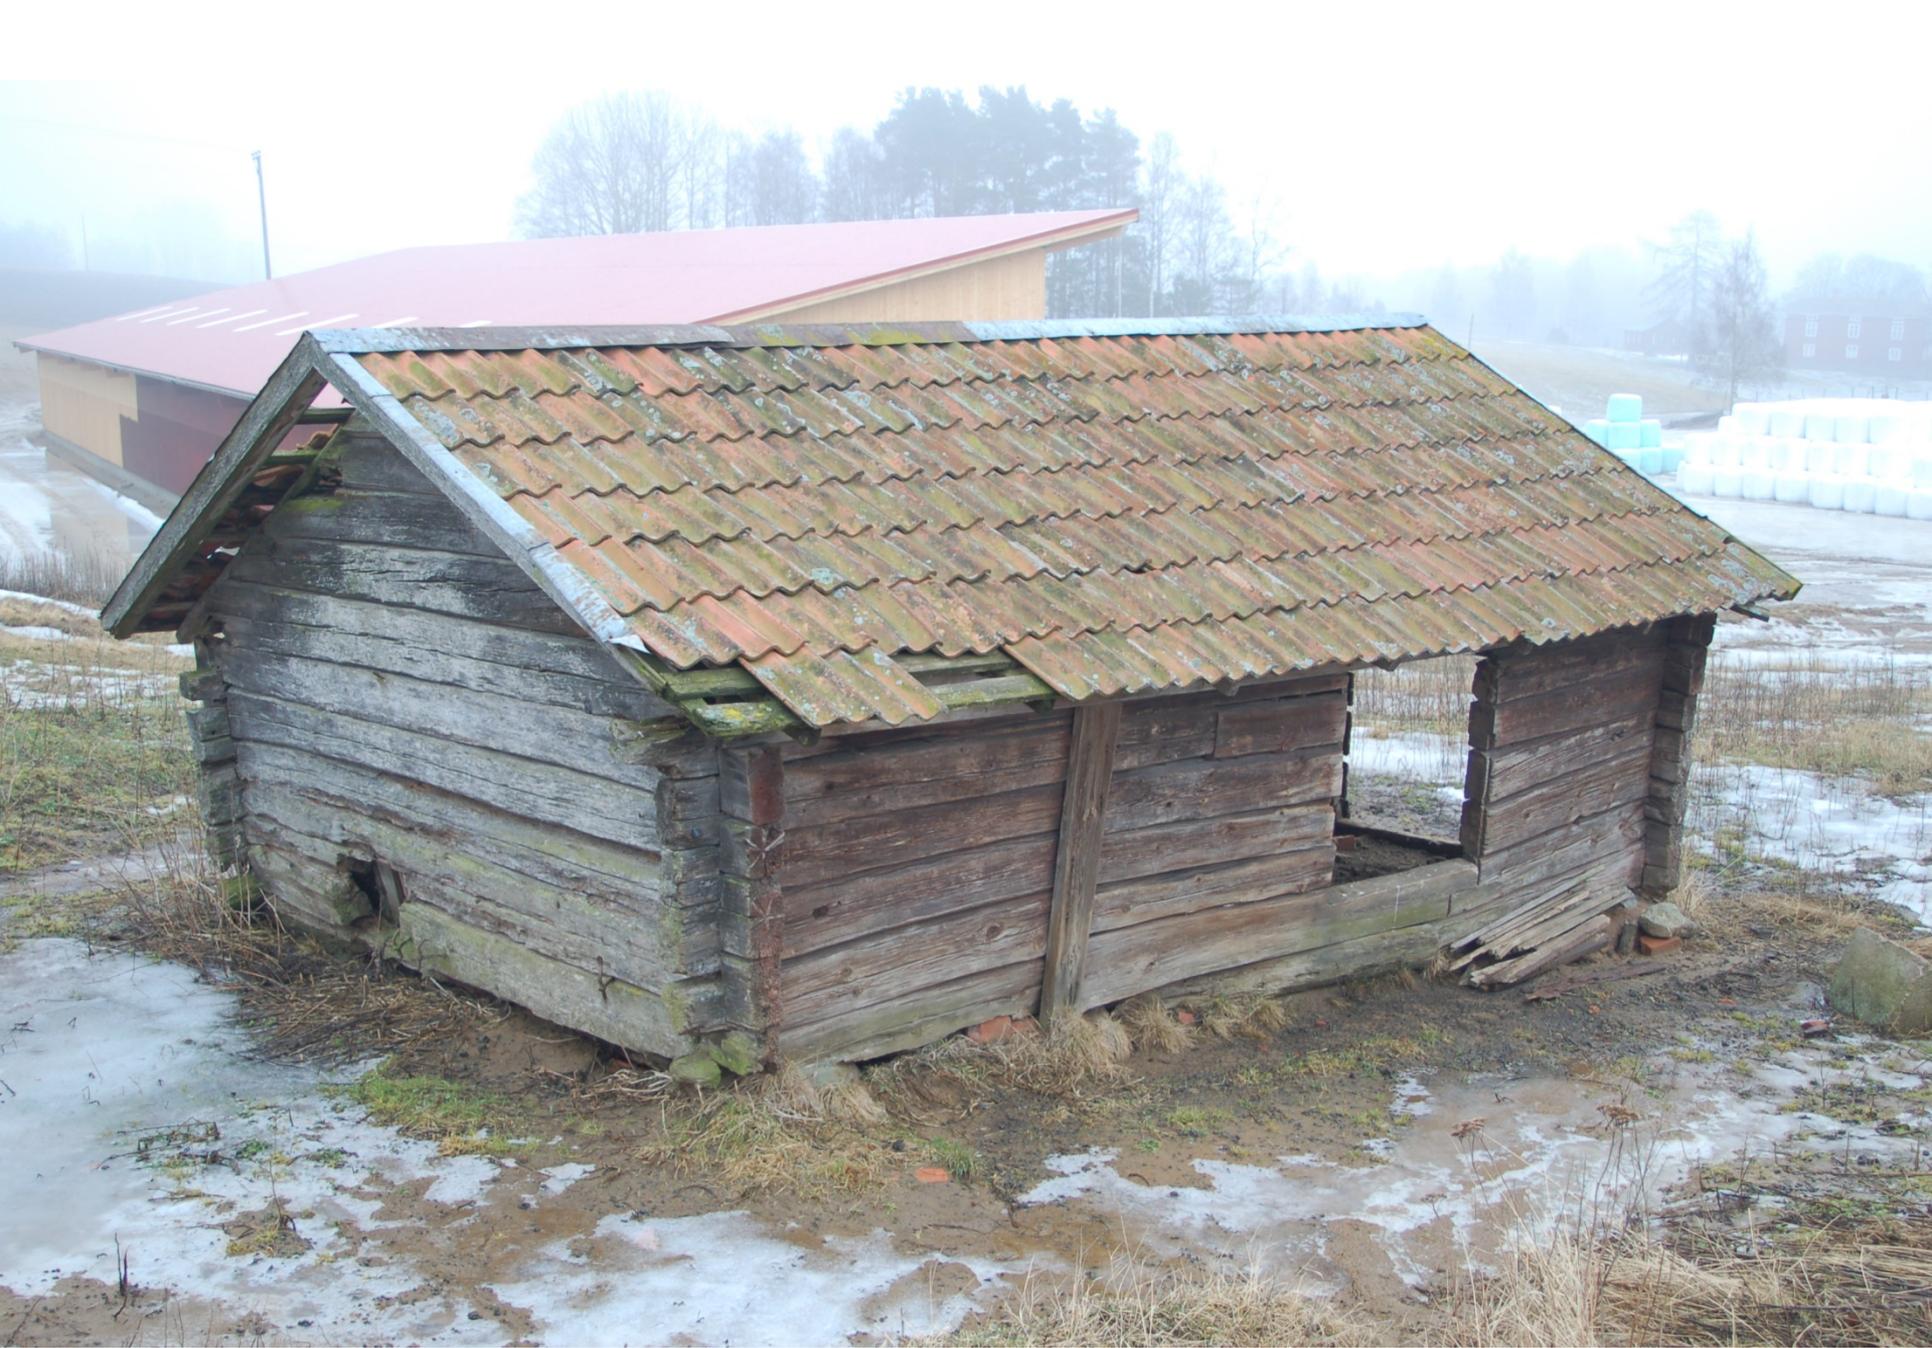
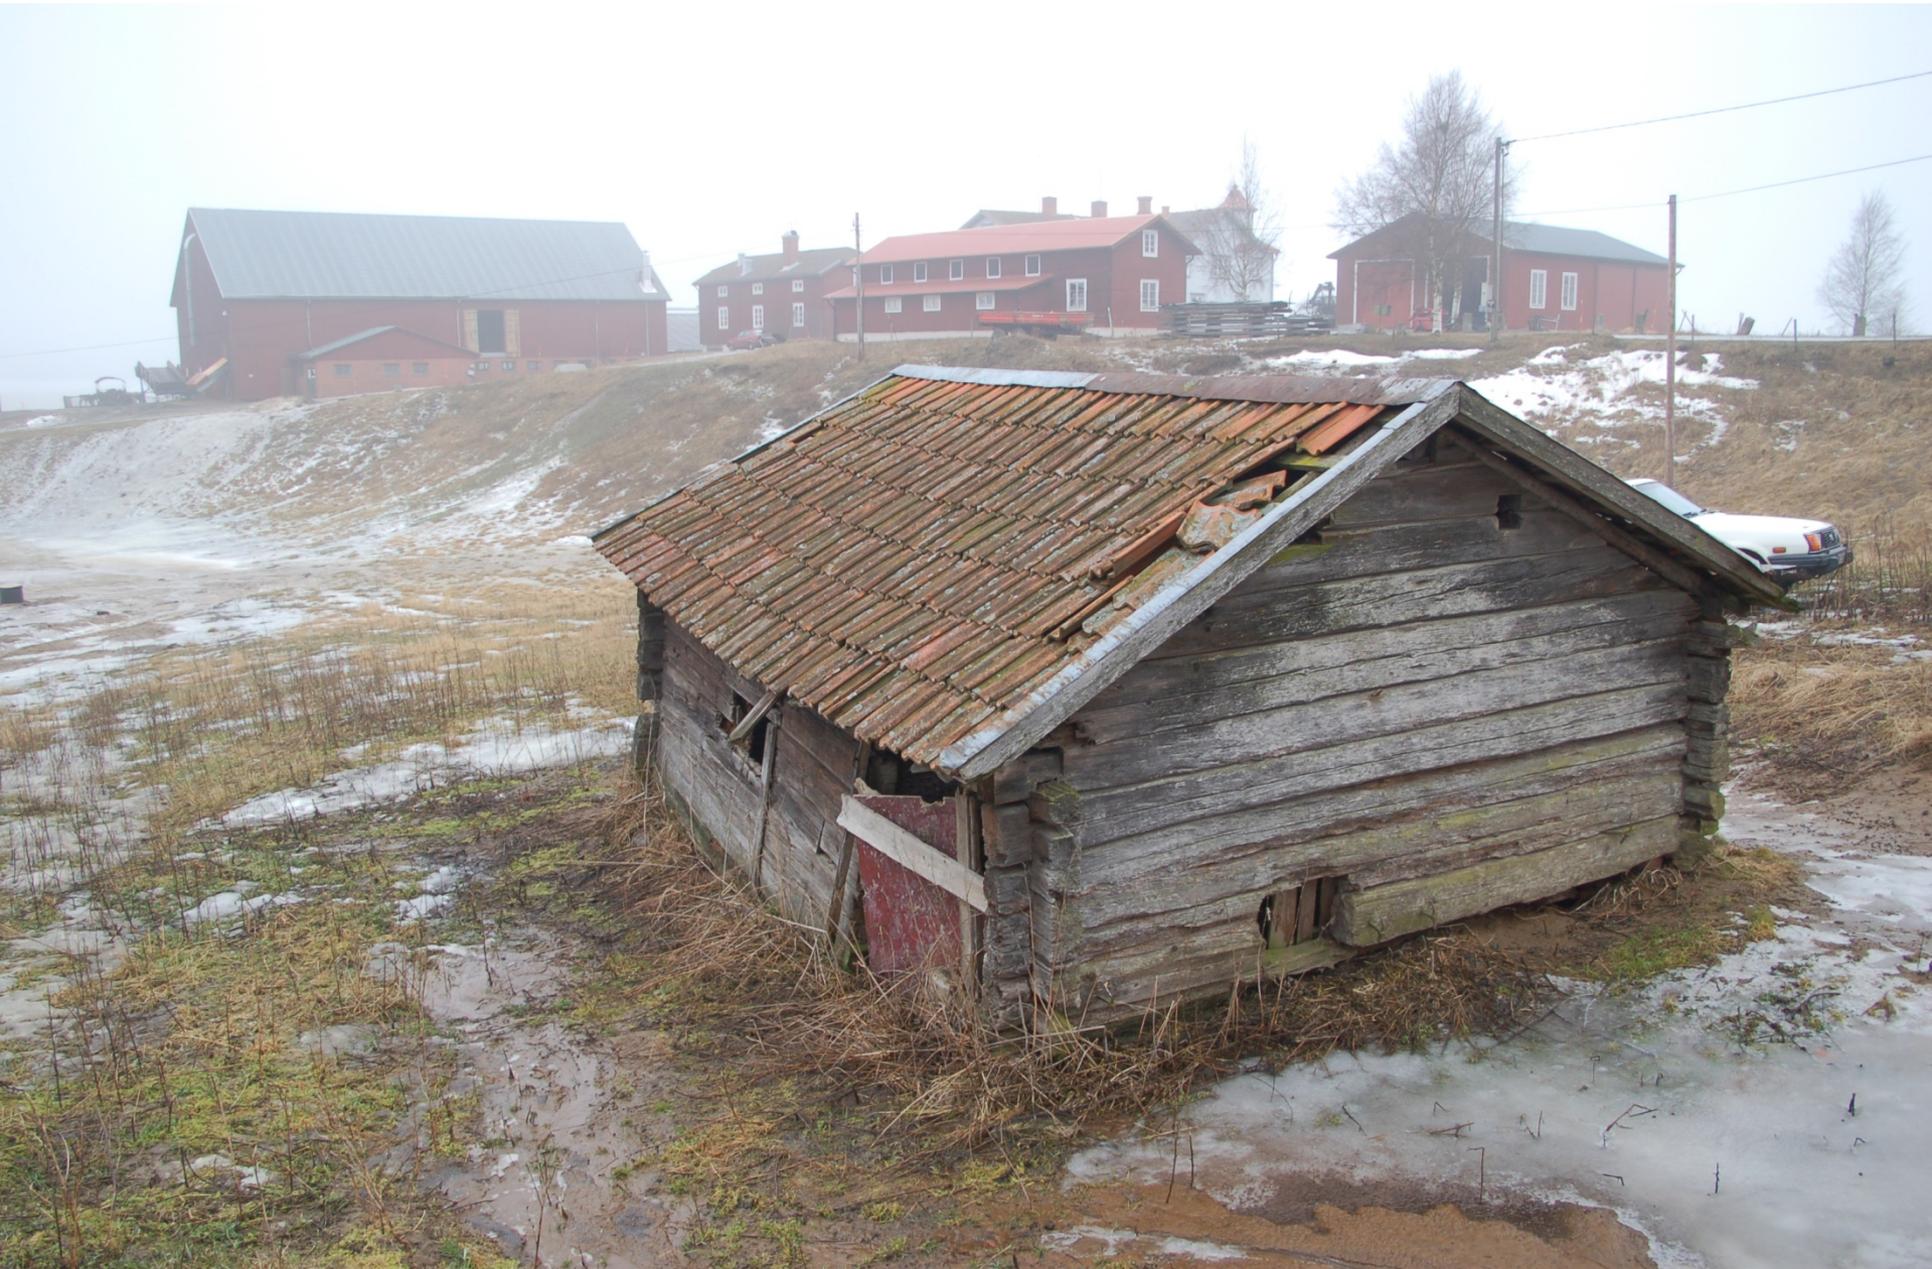
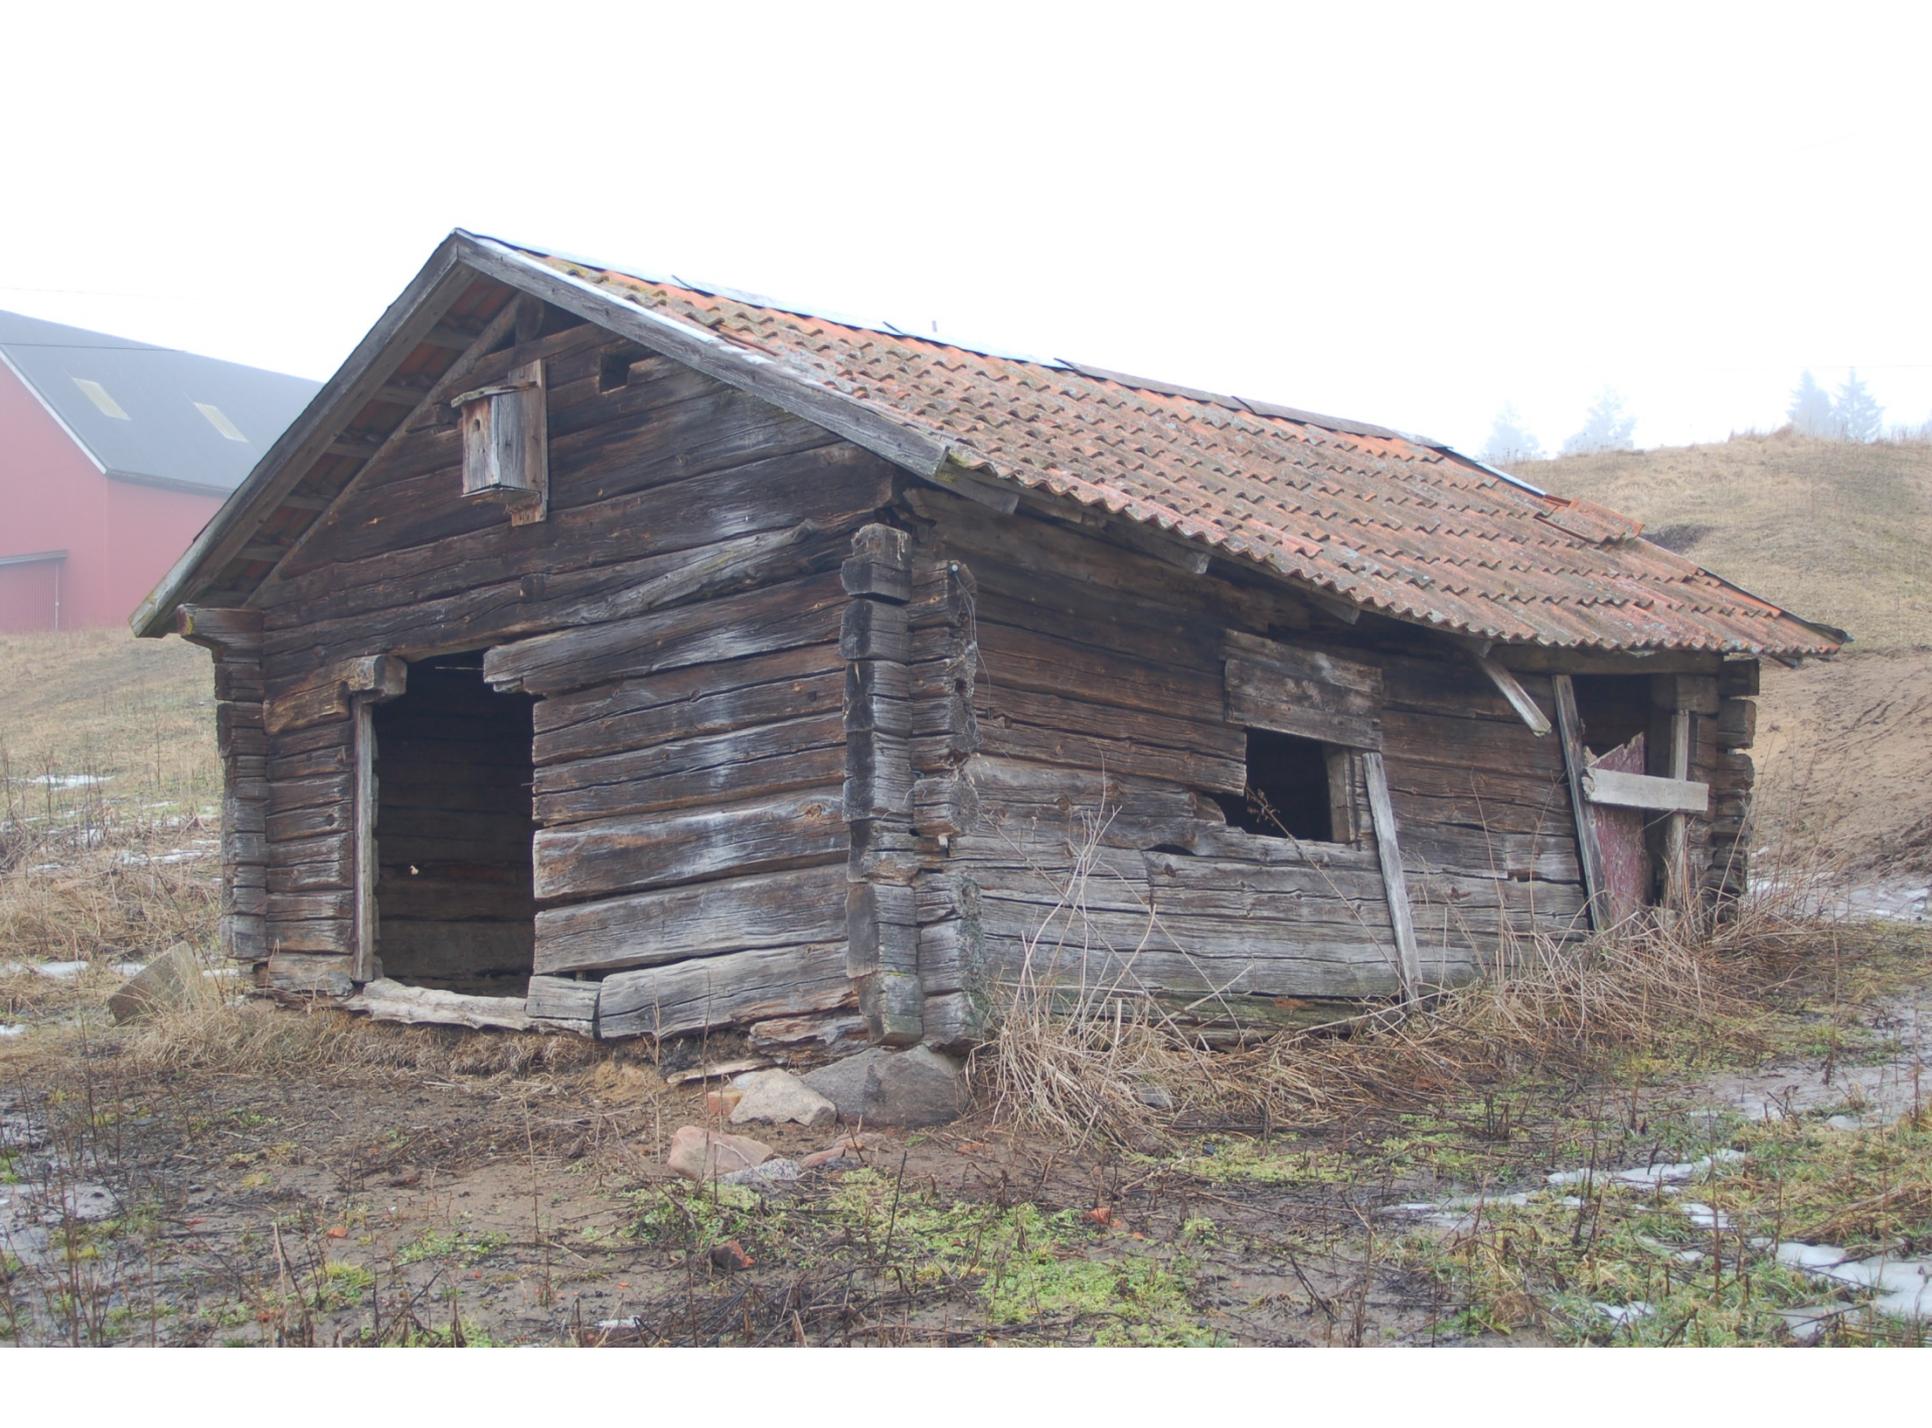
An ugly surface kan hide some fine qualities

**This log had certain rotdamages,
but the damage was not as much
as one would expect based on
the exterior view.**

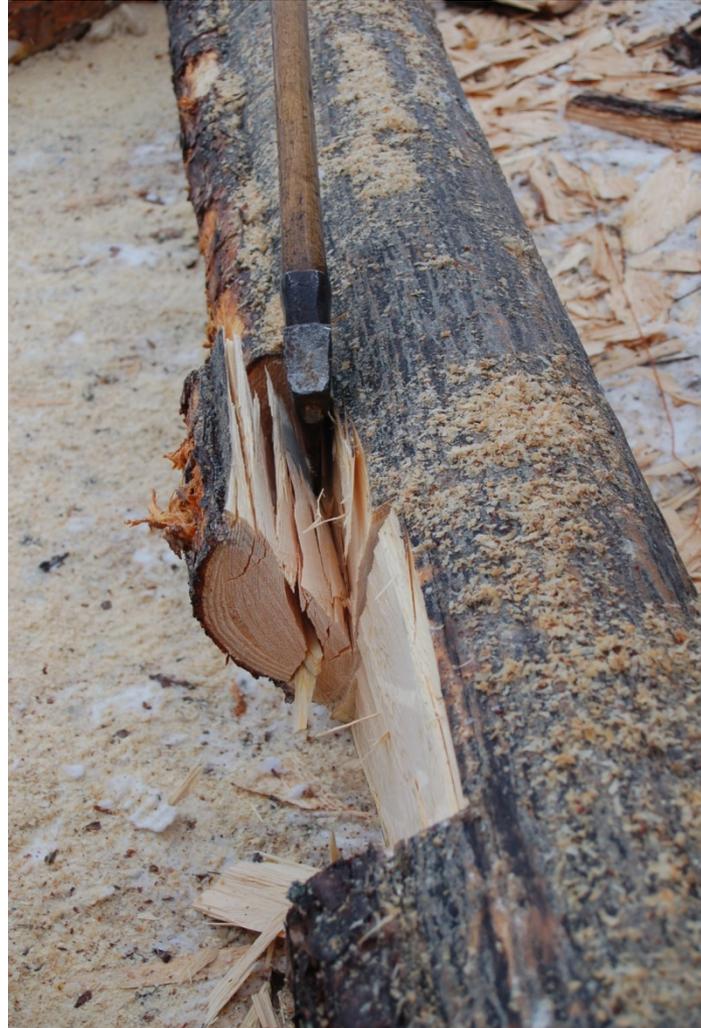
Hewing the timber

Traditional method for hewing 6” timber.

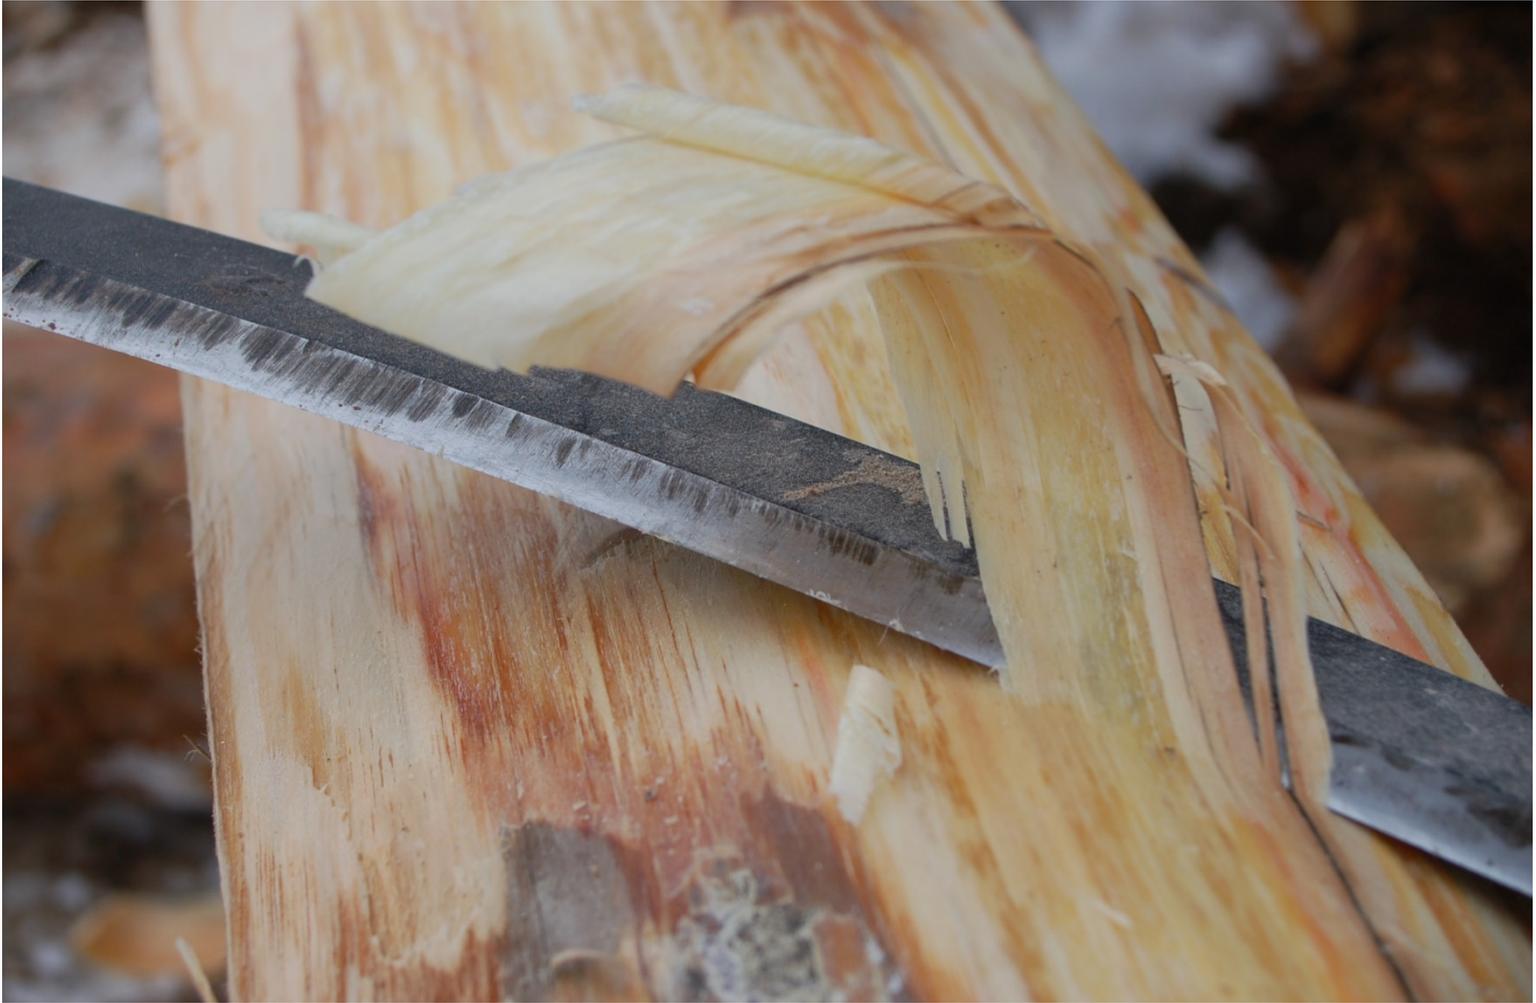
Fineadjustments of a fatwood log with a bandknife.

Fineadjustment of the knothead

The old knotheds where chopped by an axe so the new ones were done in the same manner.

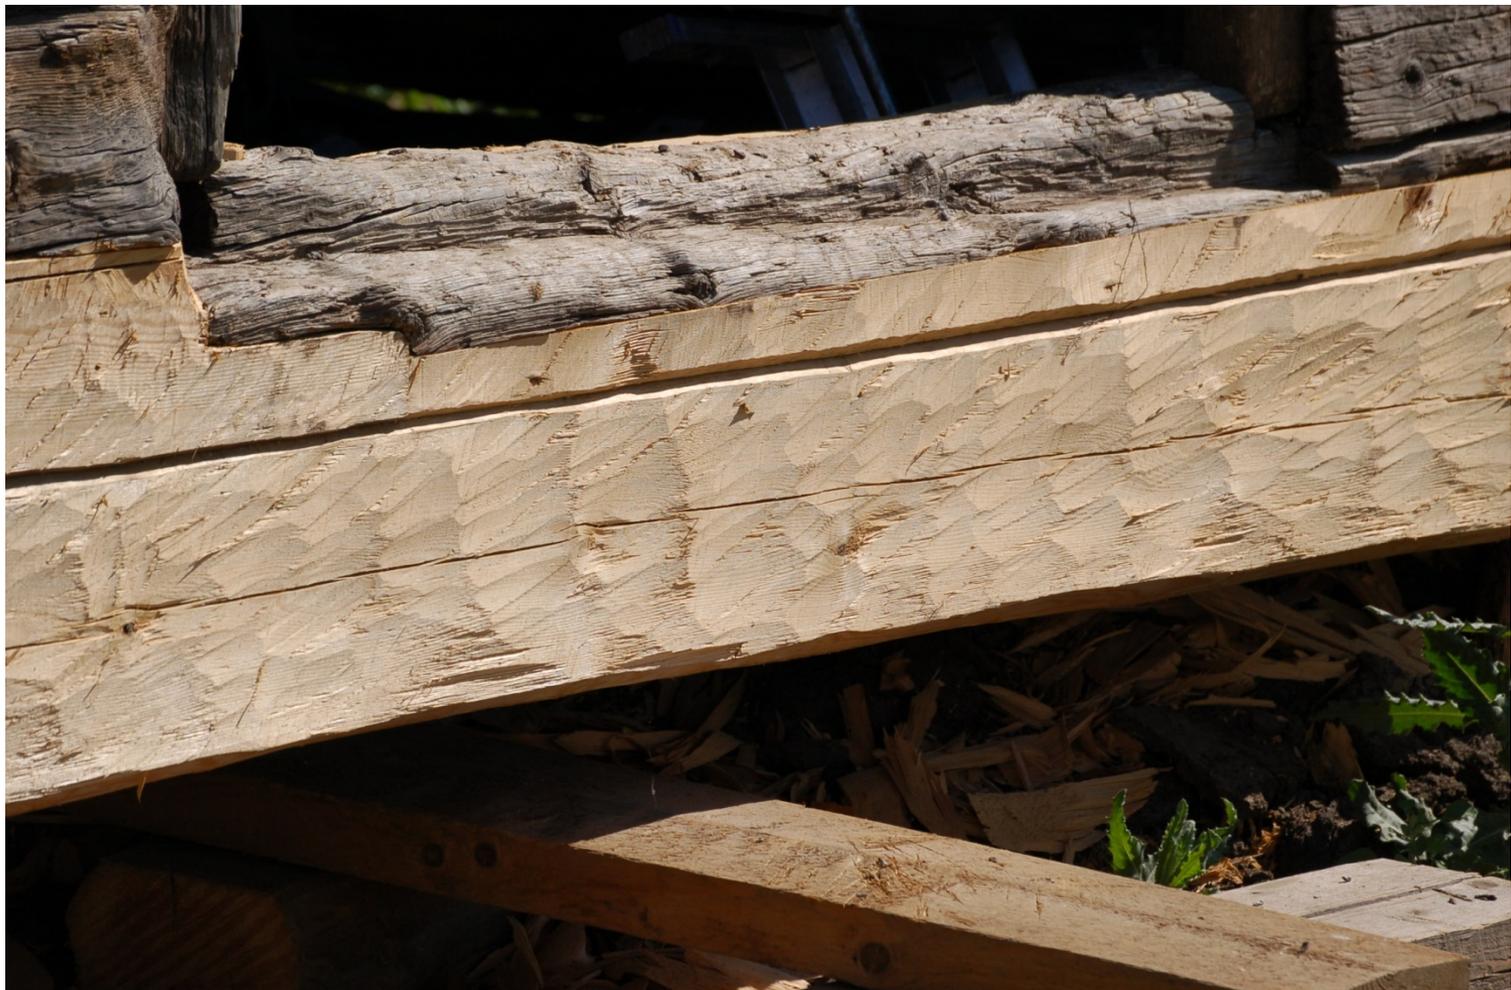
Fitting the sill

Here it's important to keep the door threshold with all its wear and tear to preserve the history of this forgecabin. If it would be completely replaced with a new one, an important historical piece of the puzzle would be lost.
