Fatwood friends (Fetvedens vänner)

The main objective is spreading the knowledge about artificial aging of trees.

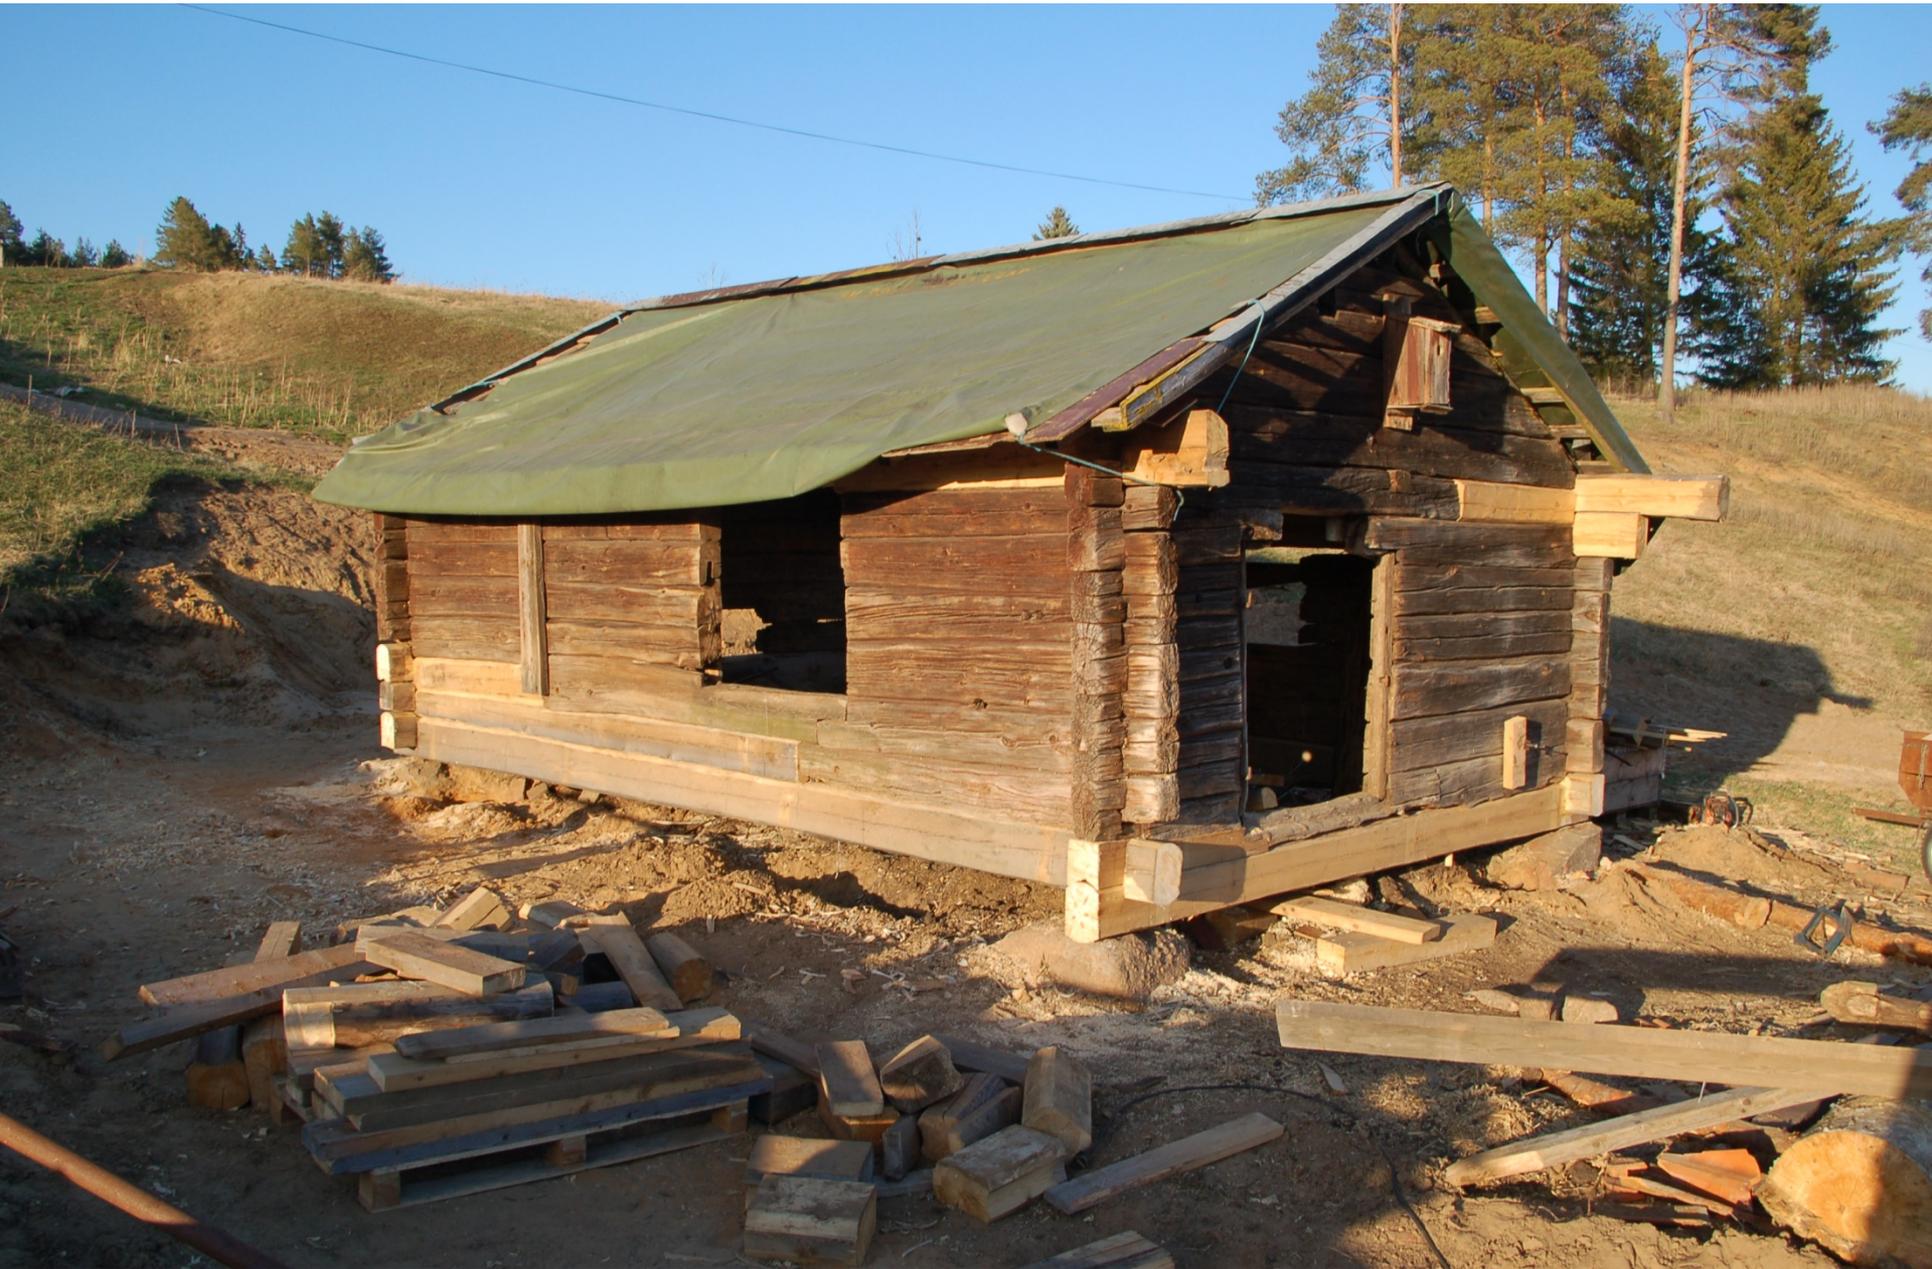
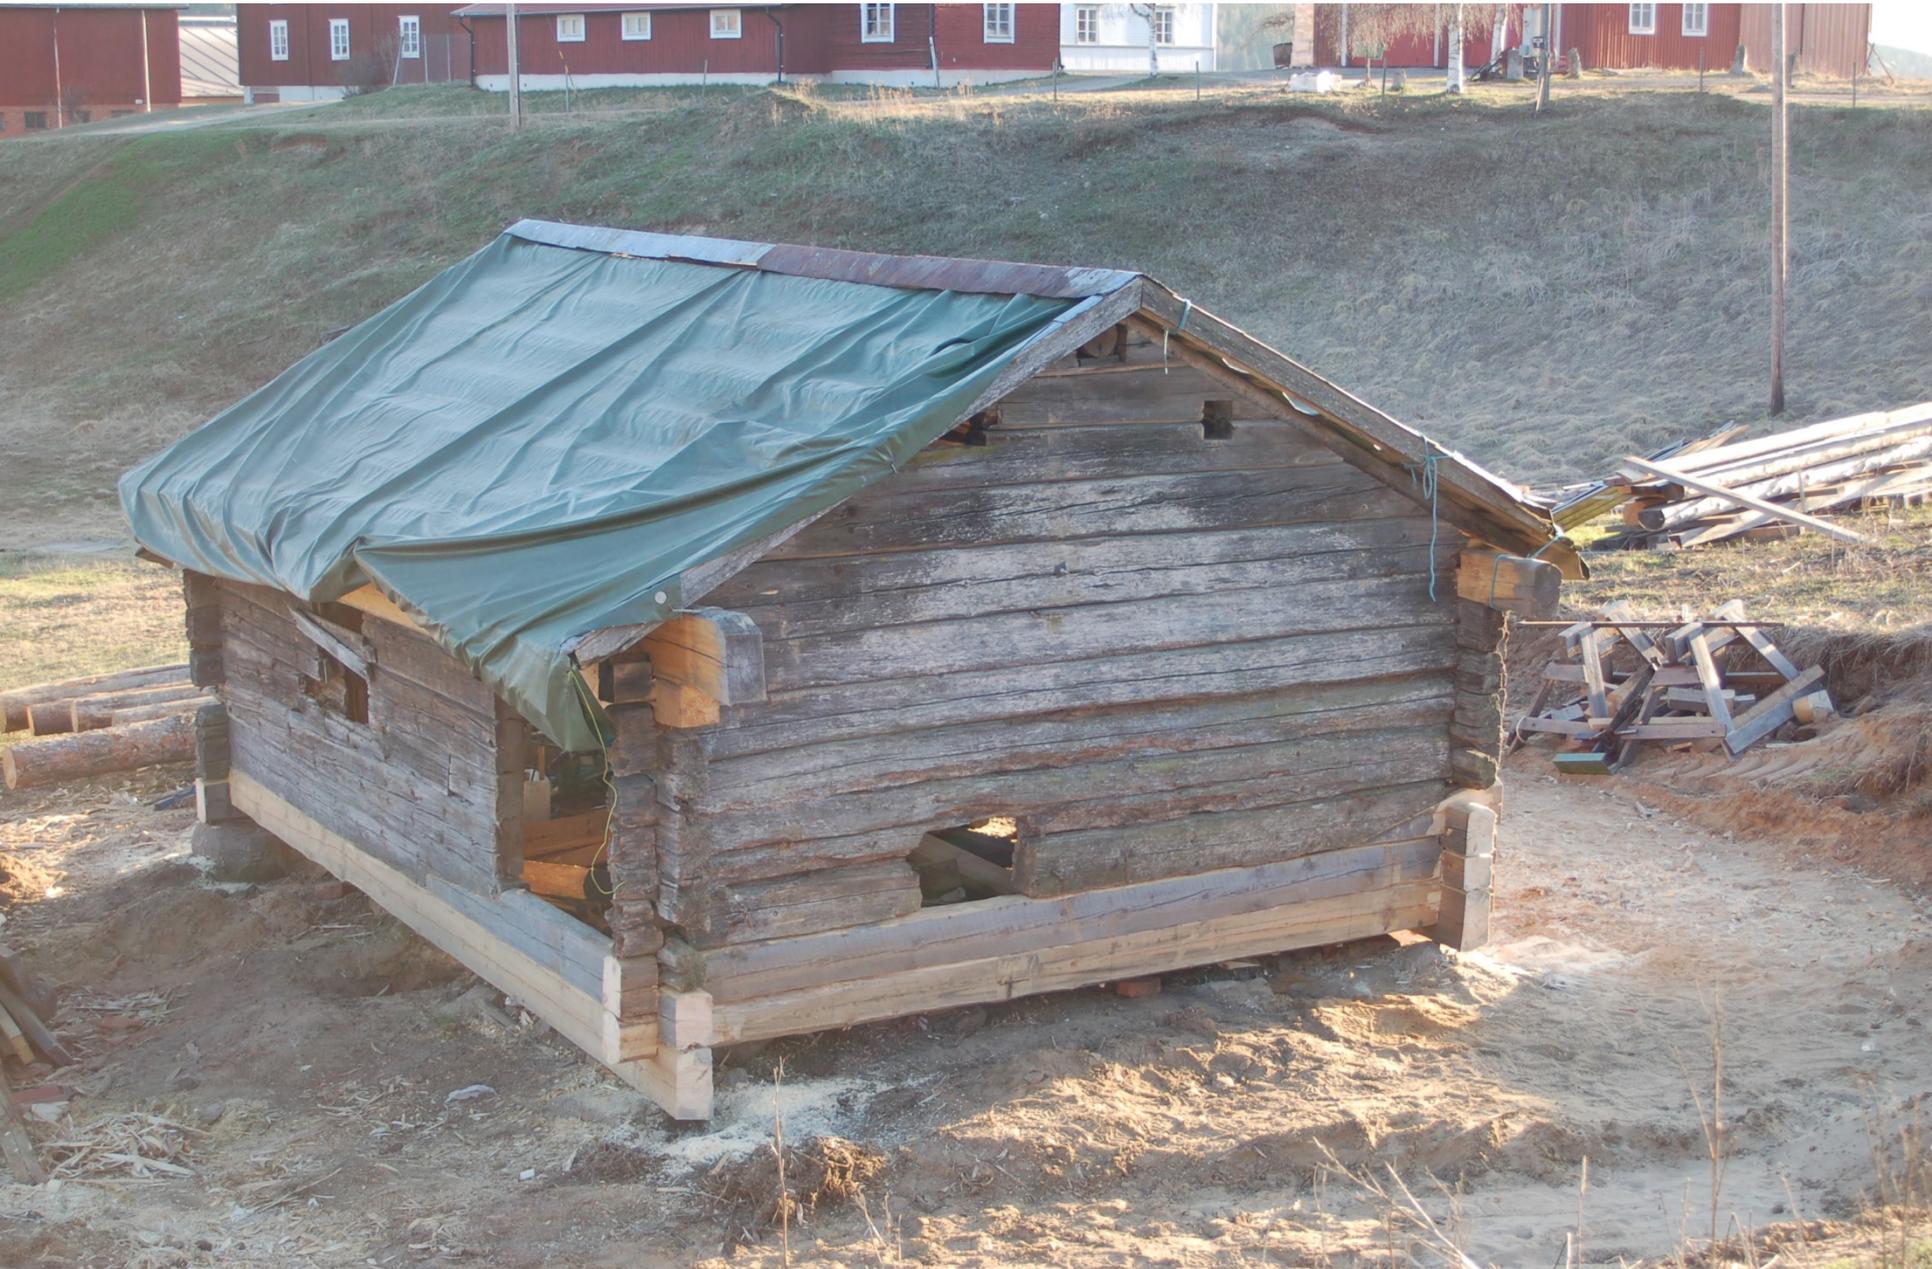
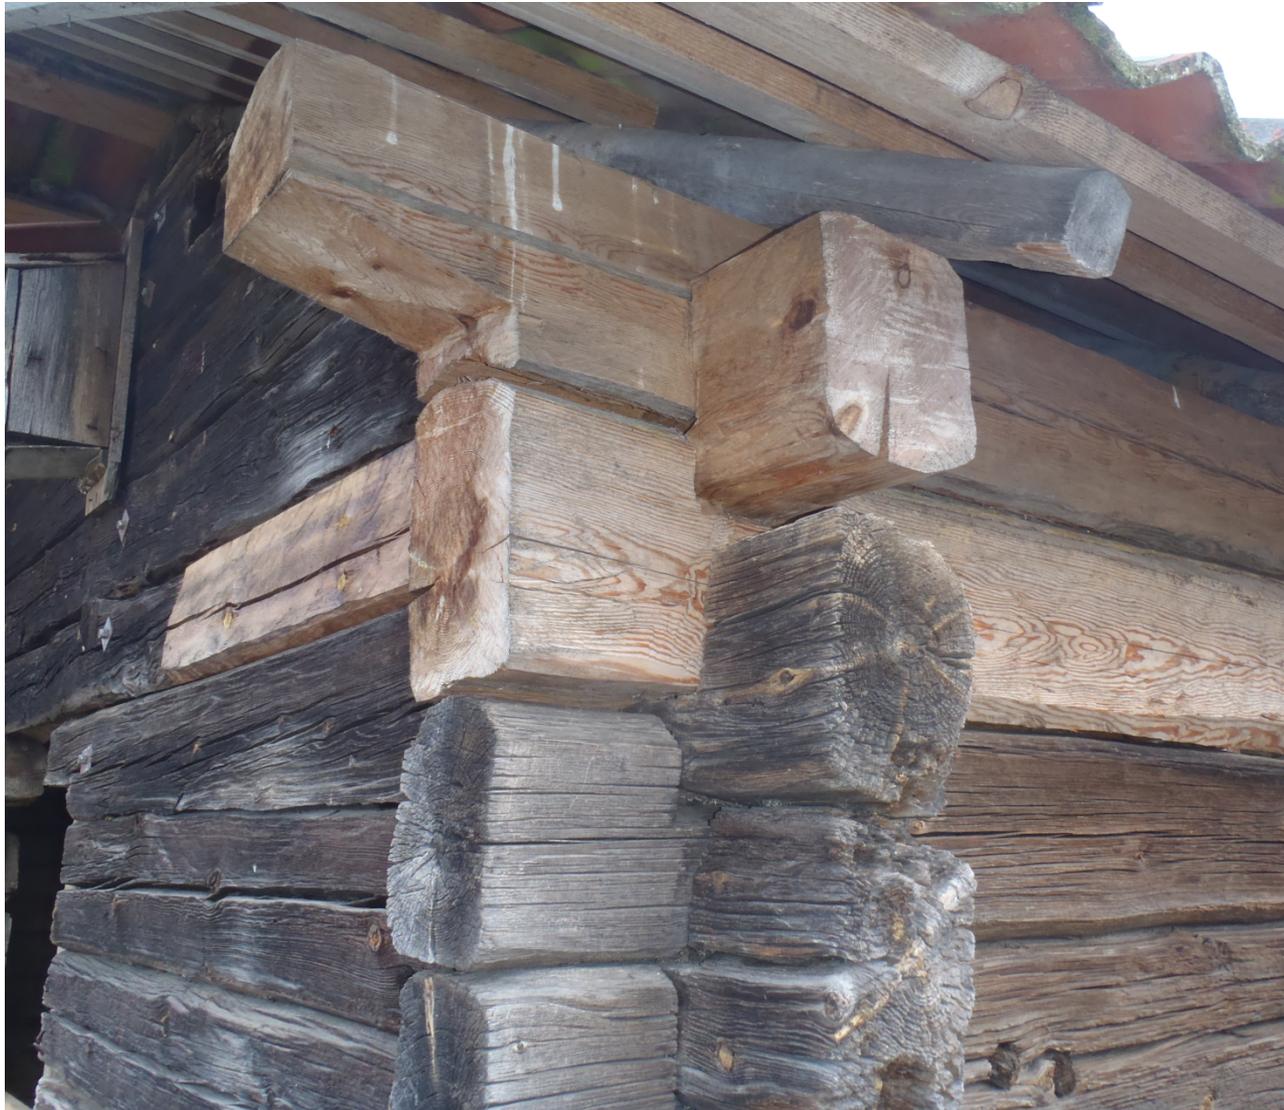
Incorporated fatwoodlogs

In traditional logging one has always aimed to have knots in the knoheads. This is also done in restoration works.

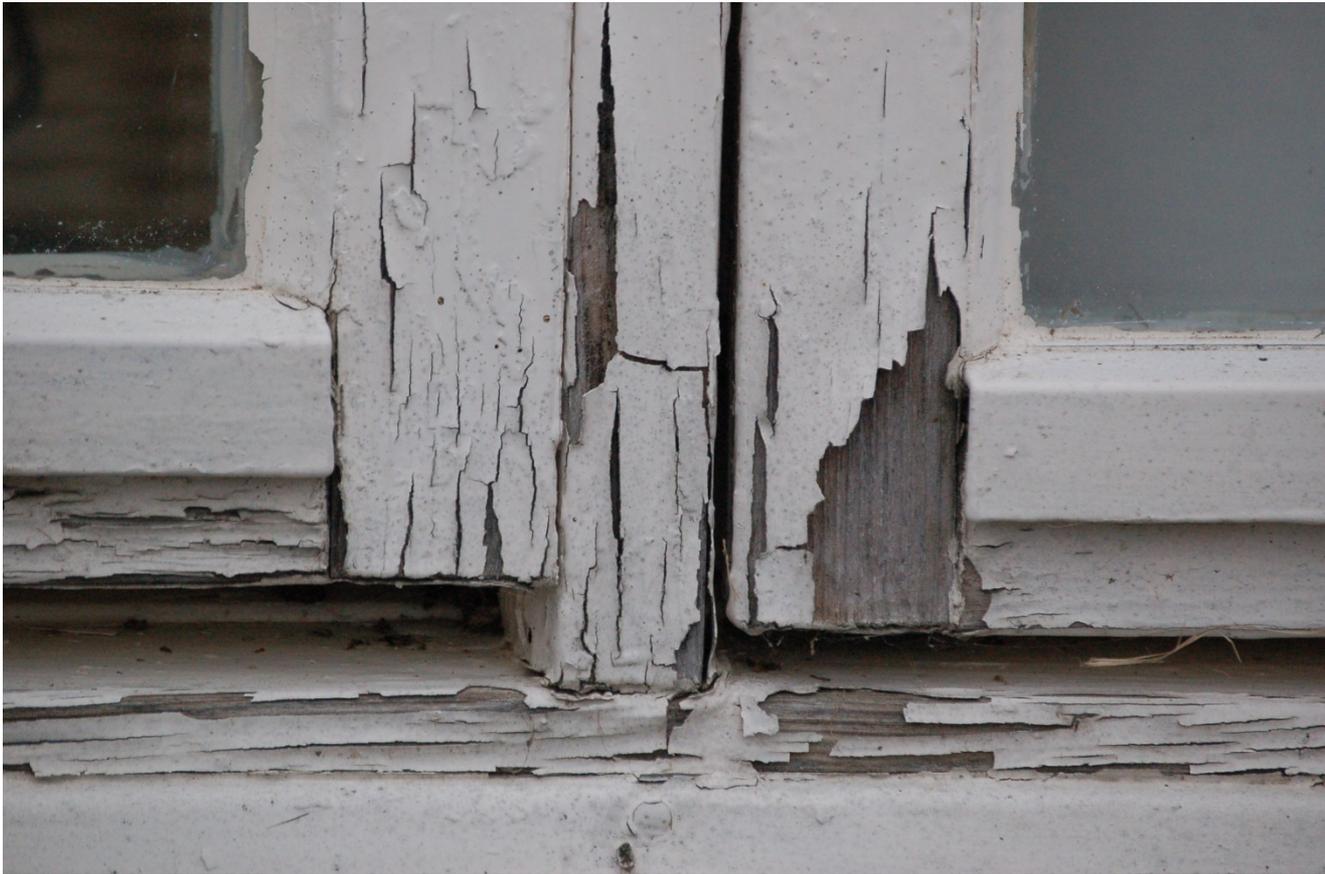
Window from the 1980's

The last quality windows were made in the 1950's and are still good today.

The windows in the picture are made of bad quality that attract moist and makes the wood swell. The paint also cracks and water gets in.

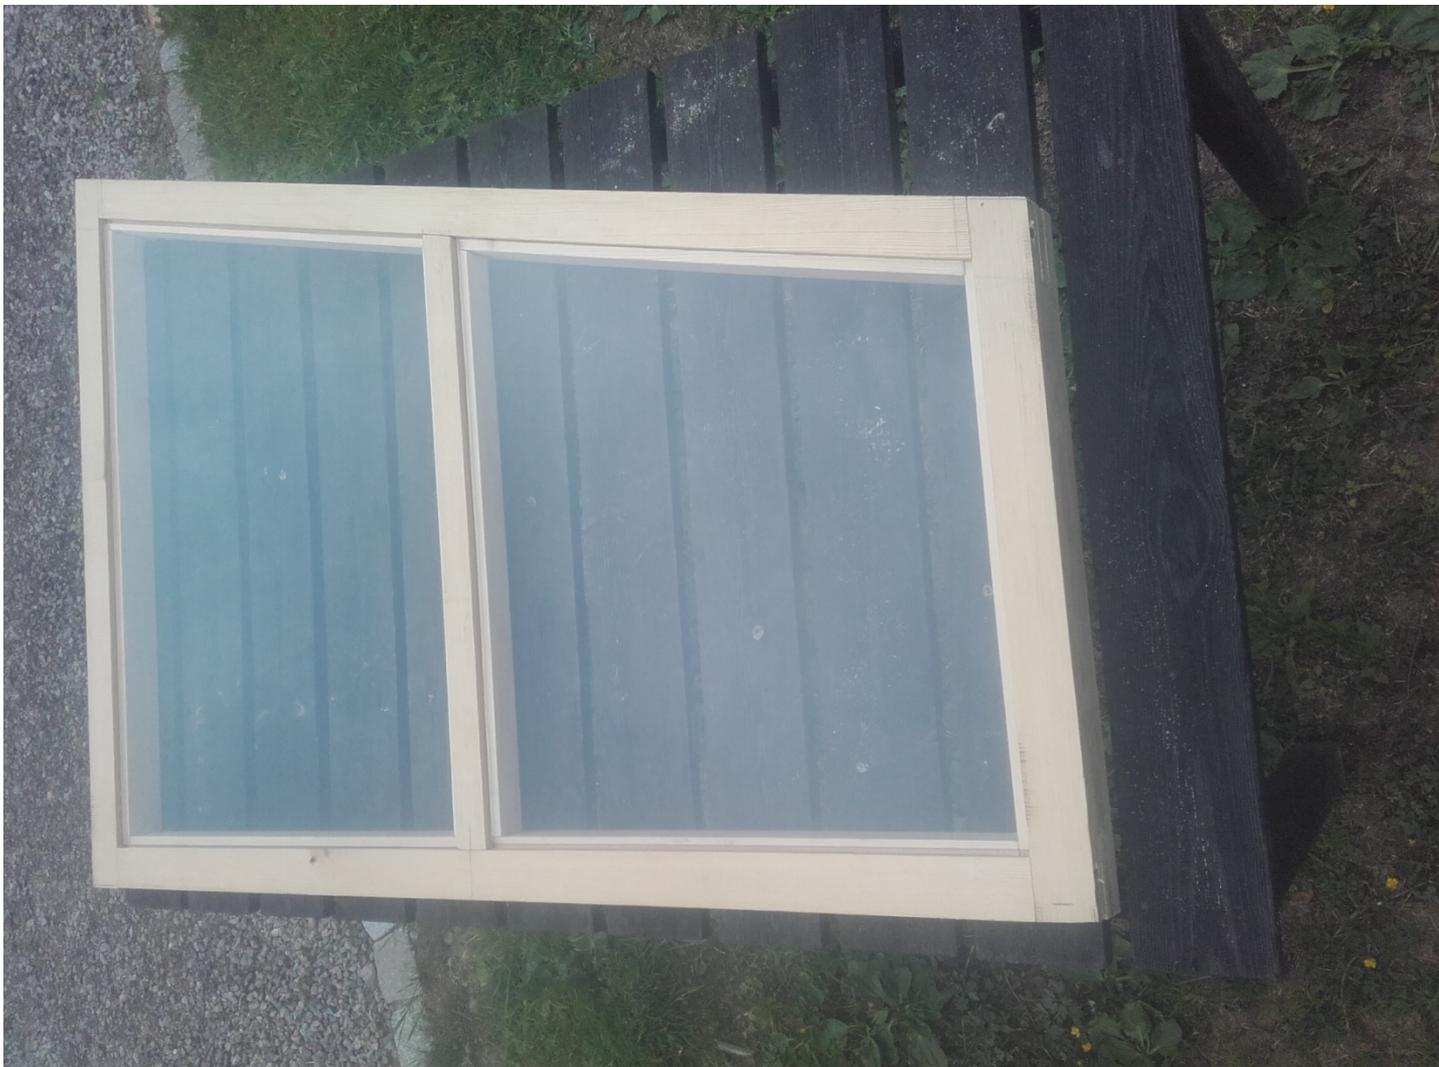
Newly made window of fatwood

The frame is constructed with standing annual rings in all directions and is mounted together using traditional joinery locked in place by wooden plugs.

Moulding planed frame

By making sure the wood has standing annual rings you will get a formstable and strong framwork.

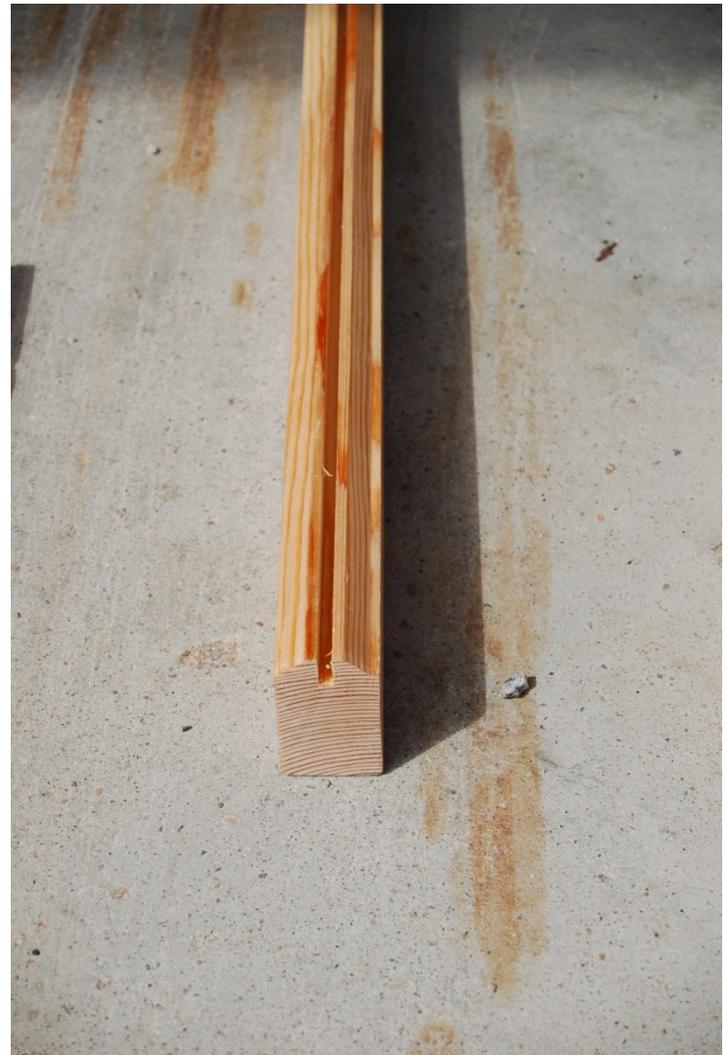
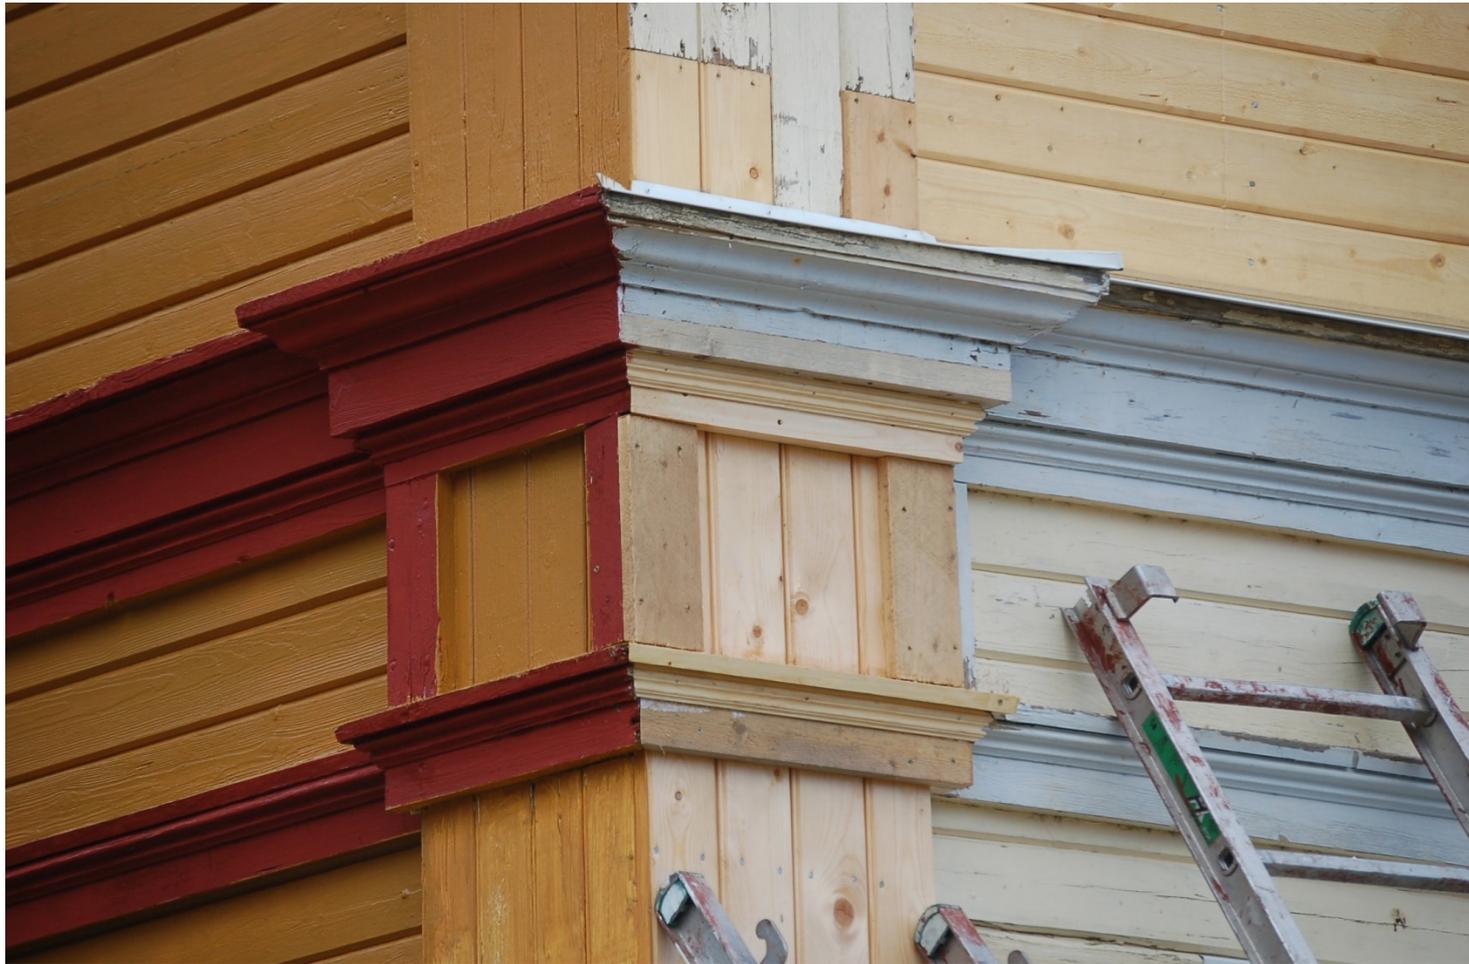
**Fatwood is an excellent choice for exterior carpentry
Here old rotten parts are renewed using high quality fatwood.**

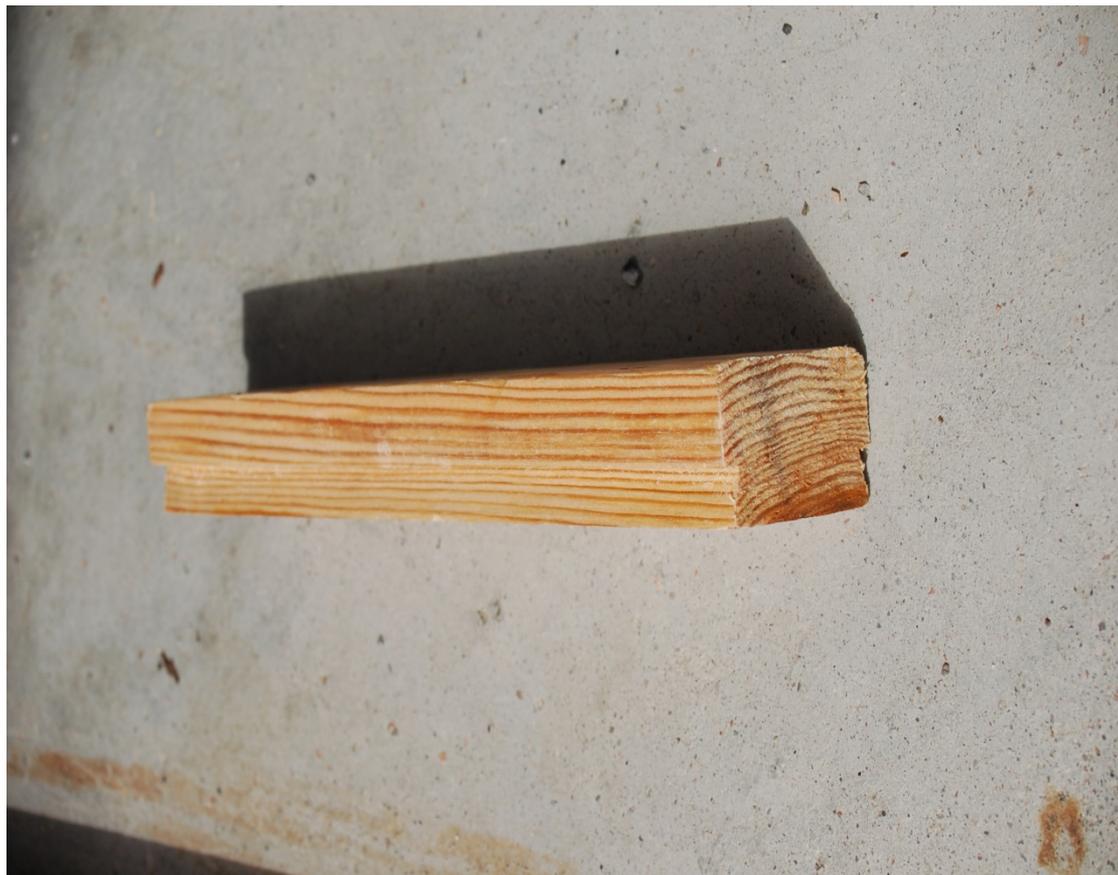
Wooden wedge made of fatwood for for example gates

Gates and other carpentry items are exposed to harsh weather and winds so it's important to choose good quality materials to reduce the risk of rot.

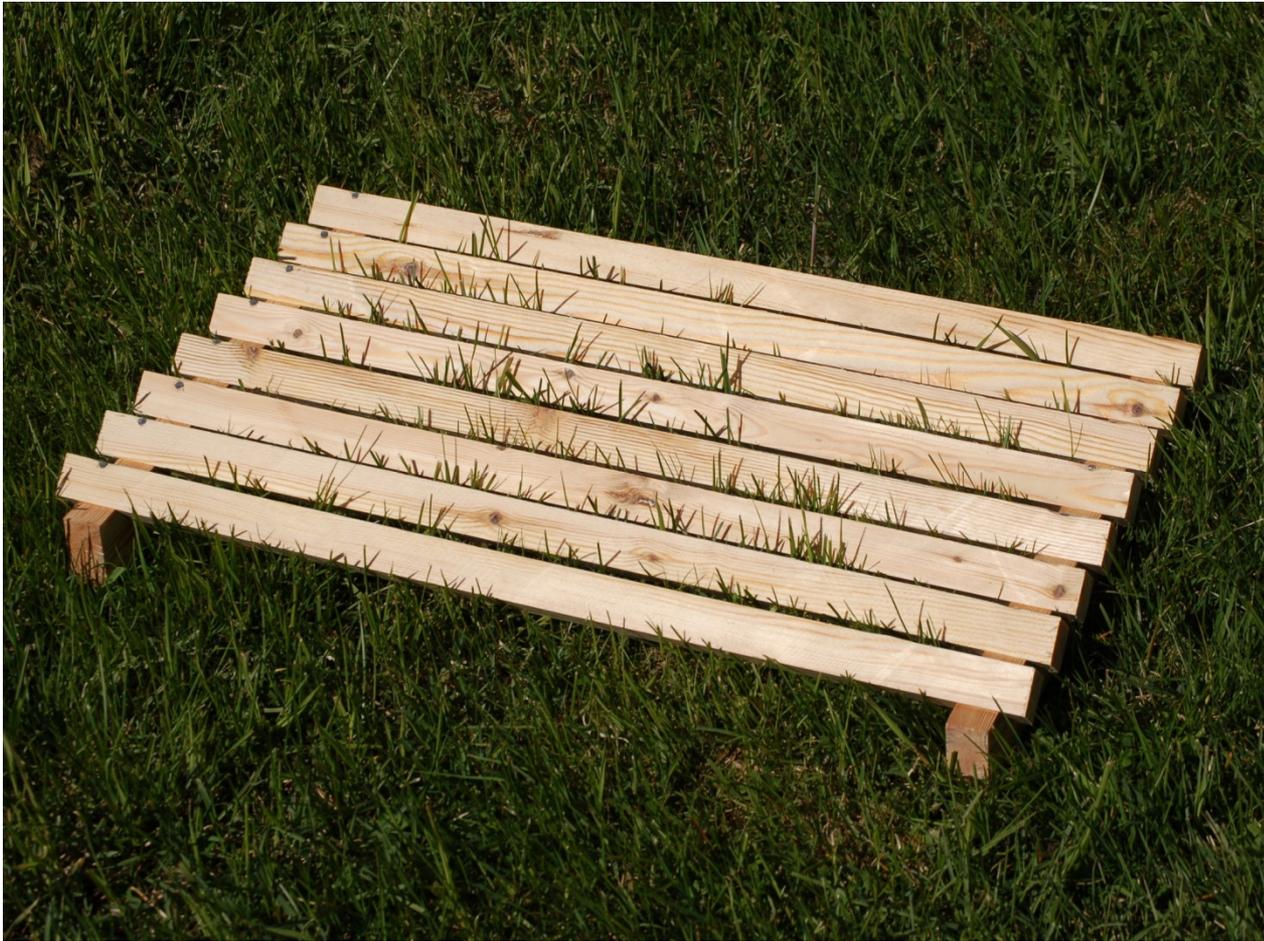
Footscape made of fatwood

This shoescape is wonderful and is found in most farms in Hälsingland, Sweden.

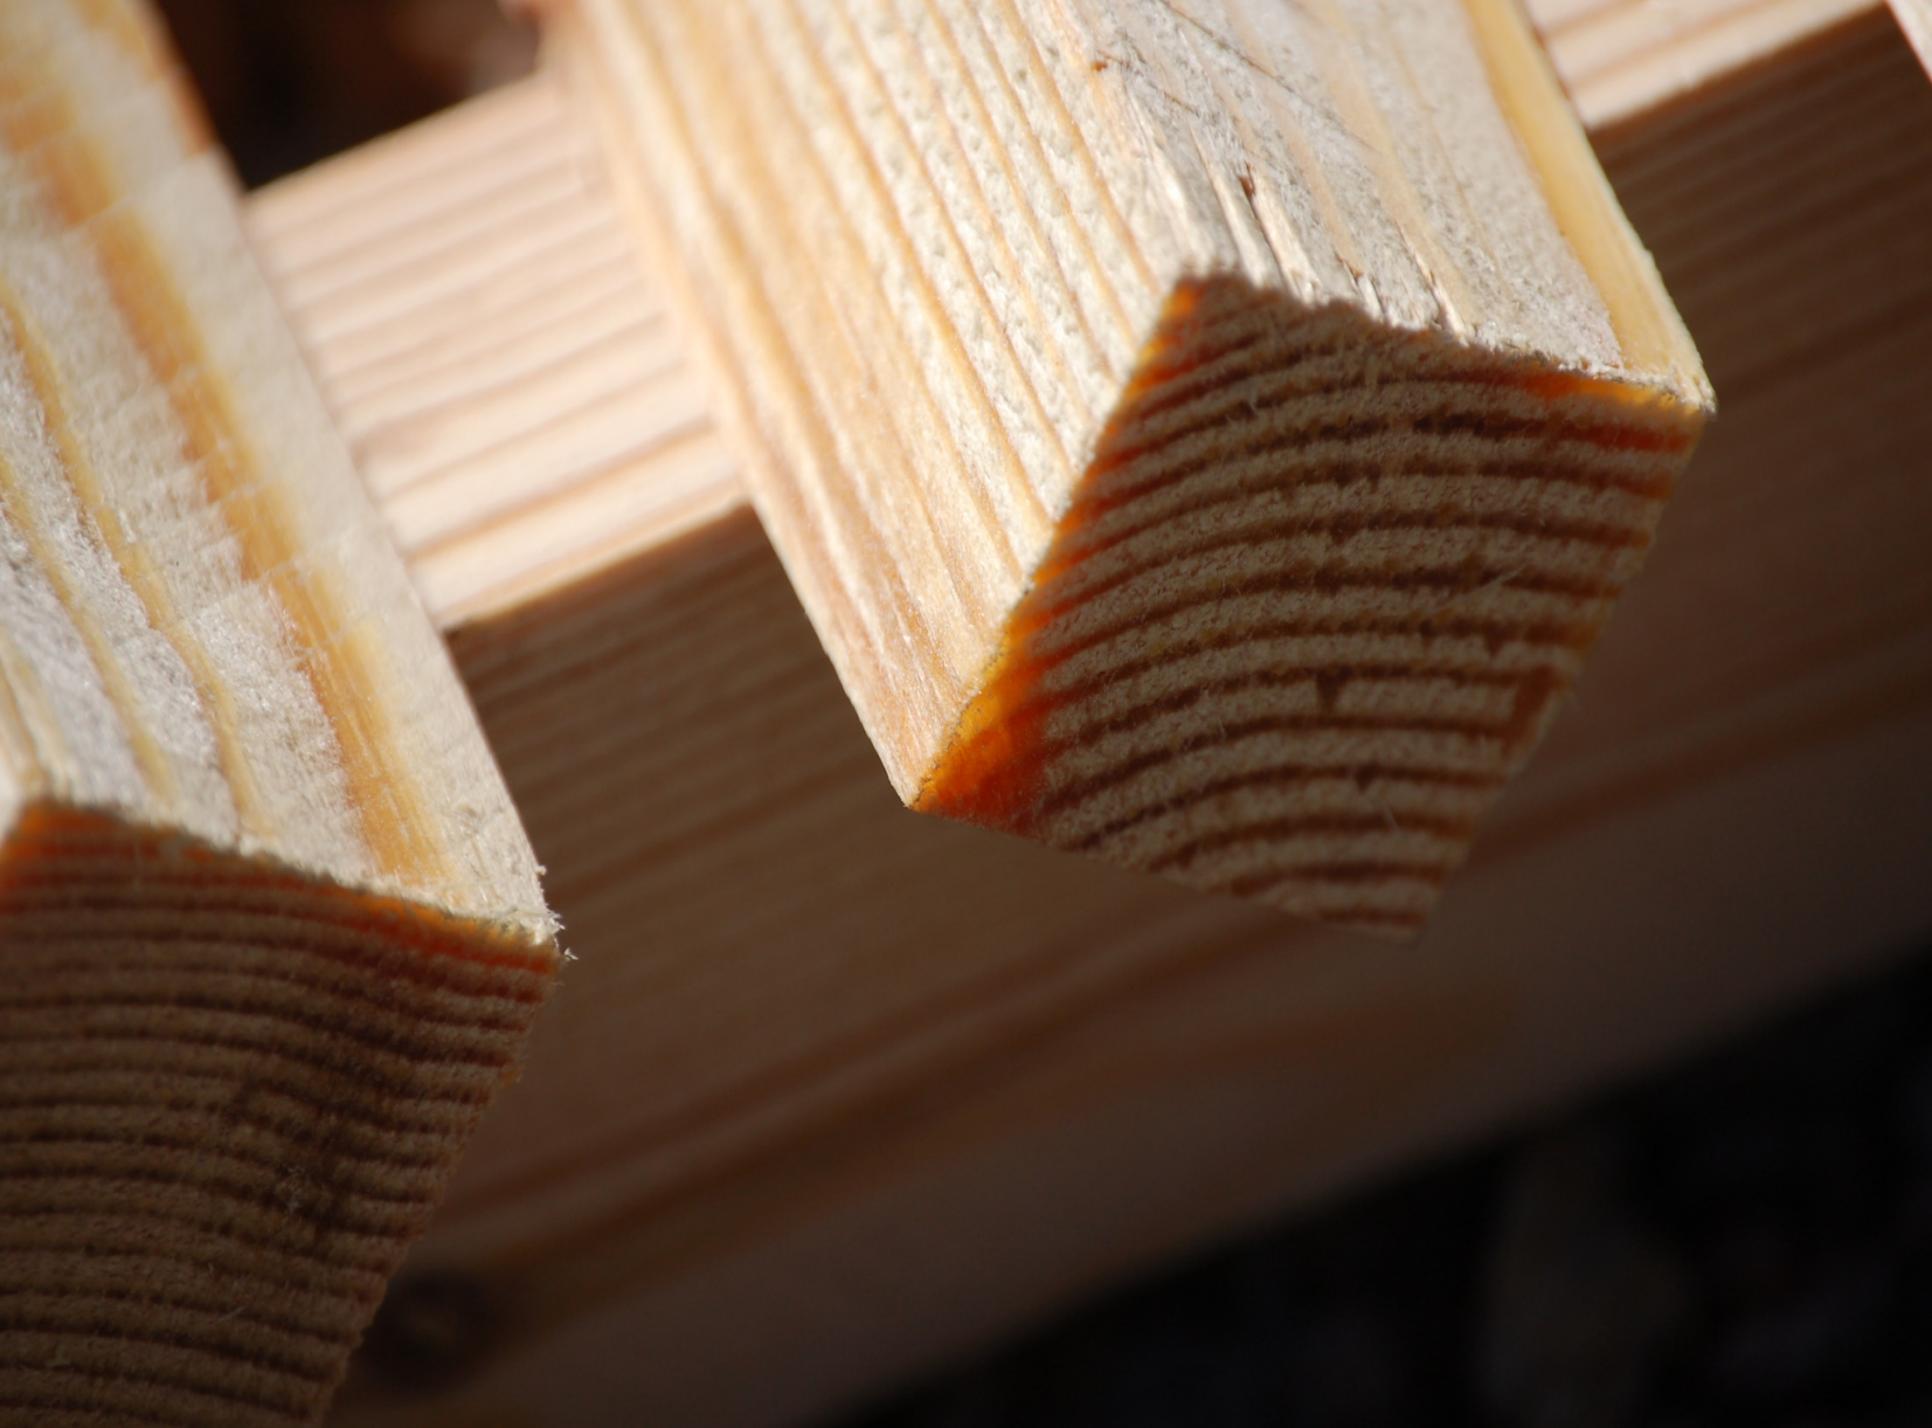
Flagpole

This is what most flagattachements look like, but by barking the tree you impregnate the wood instead and make it more durable.

In Hälsingland, Sweden there is a flagpole which was barked and put up in 1902 and it still stands today.

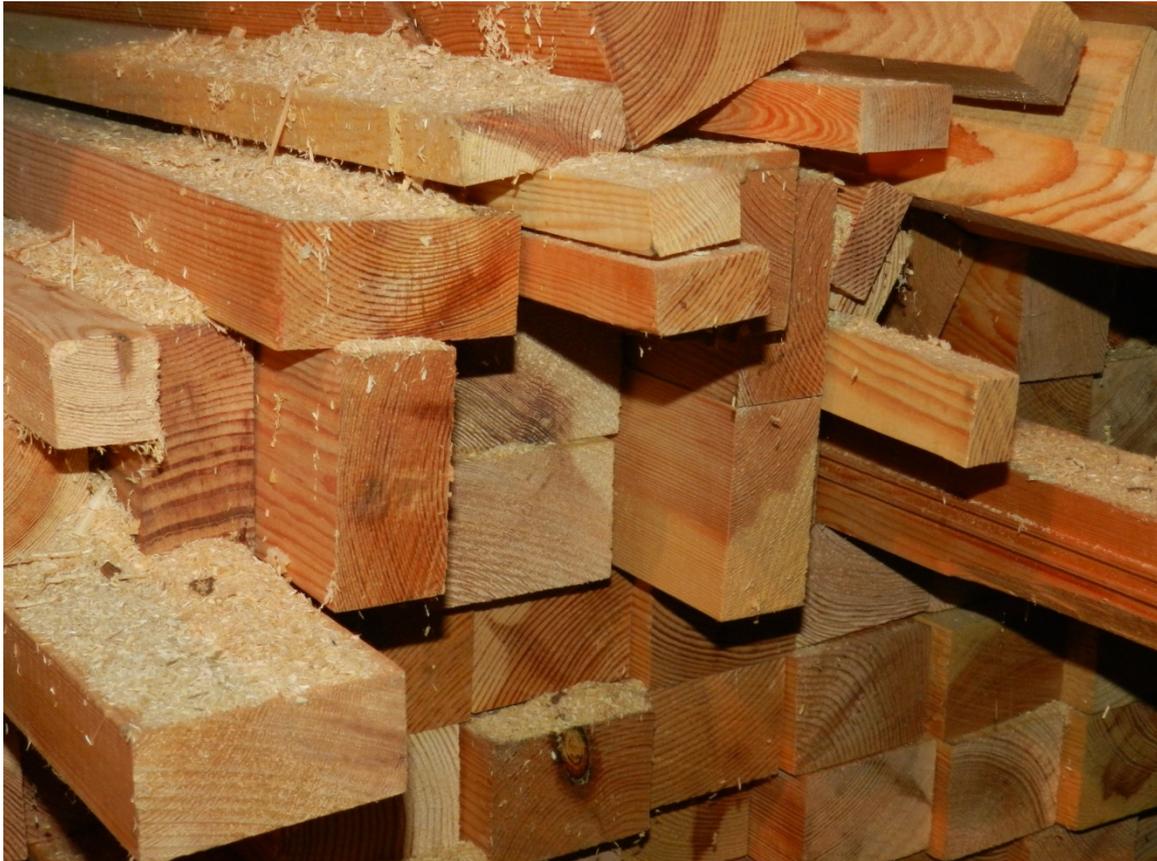
Fatwood battens

This fatwood material we buy from modern windowproducers. They are too fat with resins so they cannot glue them together.

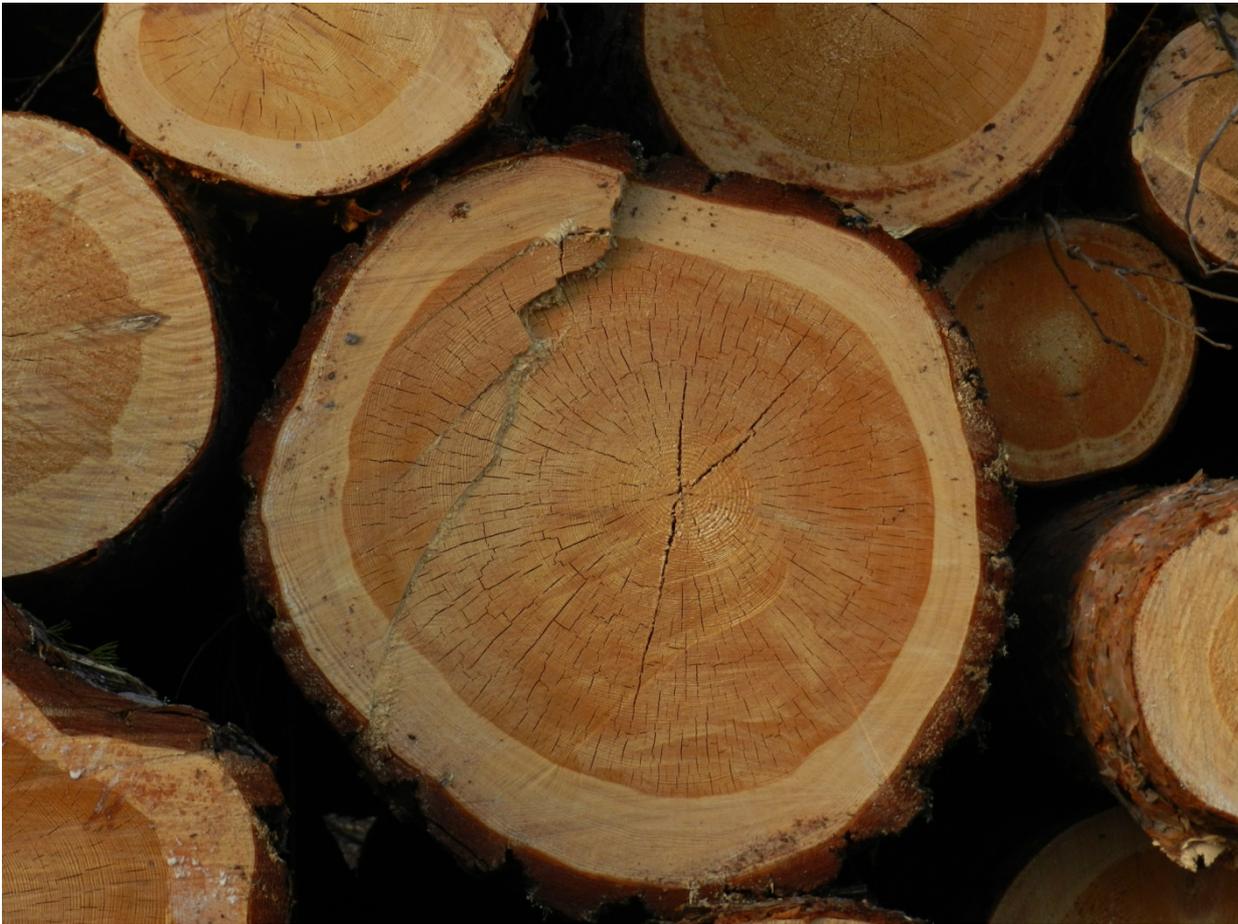
Timber with a high heartwood content

This type of wood is getting more scarce and our wood production is becoming faster and faster and the sapwood content is increasing.

As a result of this we get lesser quality wood to build houses, but through applying various methods of natural impregnating (artificial aging) we can still get a higher quality wood.

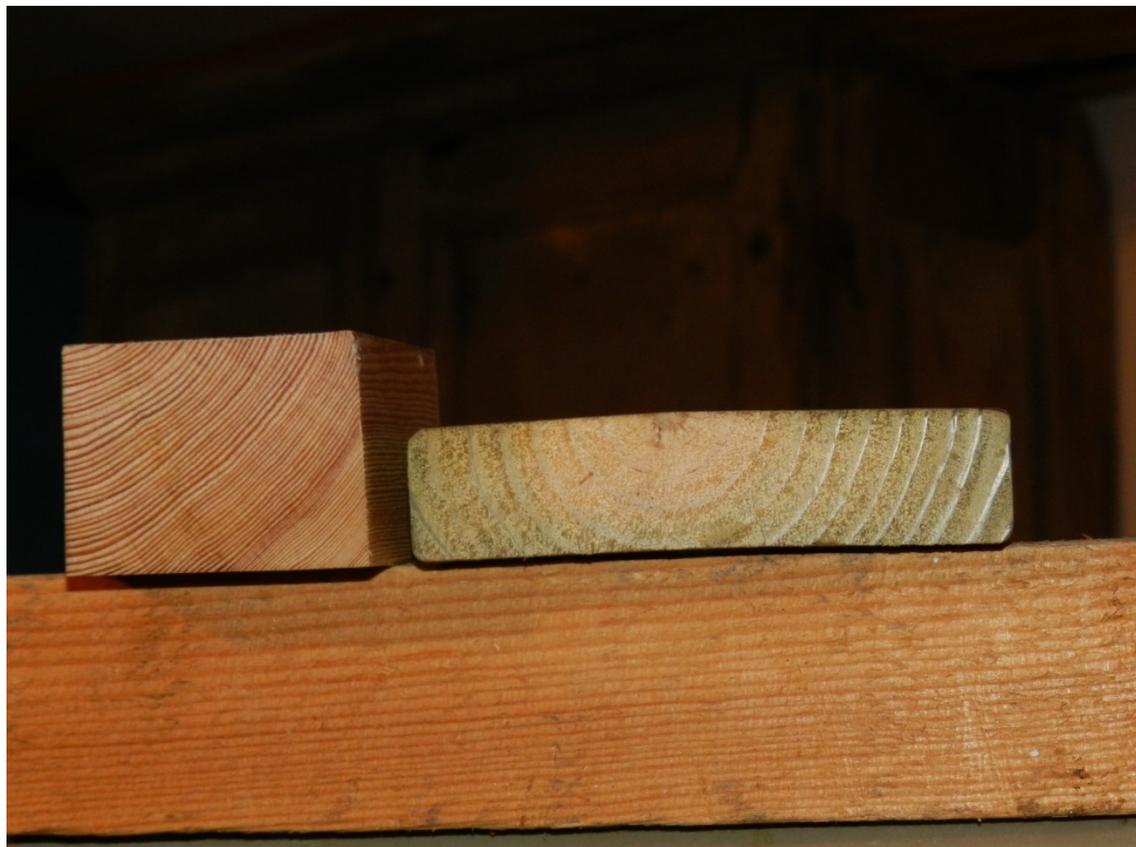
Quality differences

On the left we have quality wood with standing annual rings which are tight and slowly grown.

To the right we have a modern pressure impregnated wood which is rapidly grown. It's also clearly visible that the heartwood cannot be pressure impregnated. This method uses several toxic chemicals to make the wood more rotresistant

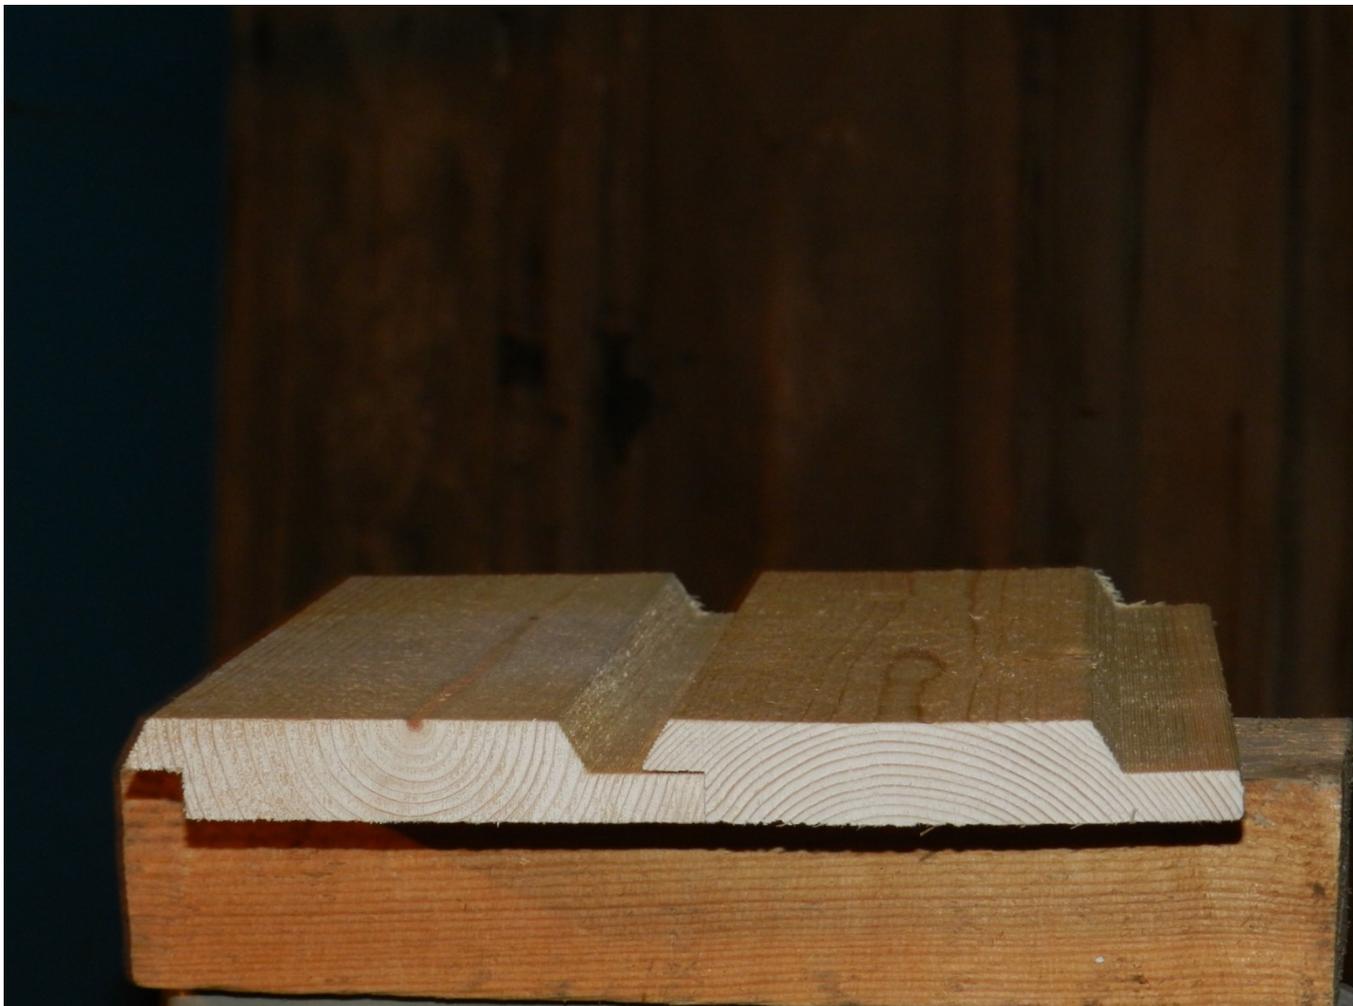
Modern sawmilled product

Here you can see a classic and bad example of sawmilled products to be used as panels.

These panels will deform differently in changing weather and moist conditions.

You must always choose the smiley side upwards and outwards.
